Access Compliance Report

Public Rights-of-Way

(Curb Ramps)

Intersection ID: 3276	Main Street: LAKE_SPRING_AV	Cross Street: W_W_T_HARRIS_BV	Location:	E
ADA ID: E20ADE4CC176	Ramp Type: Perp	Initial Pass/Fail: Fail	Overall Compliance: No	Severity Score: 8.75
Codes/Mitigation Info/Possible Solution		Field Measurements/Component Compliance

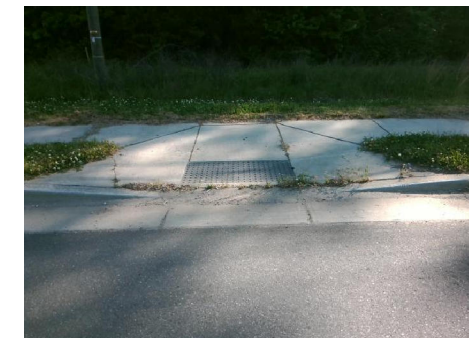
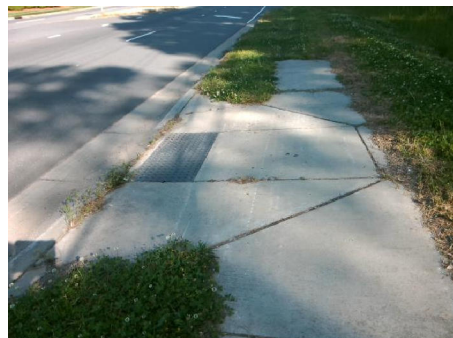
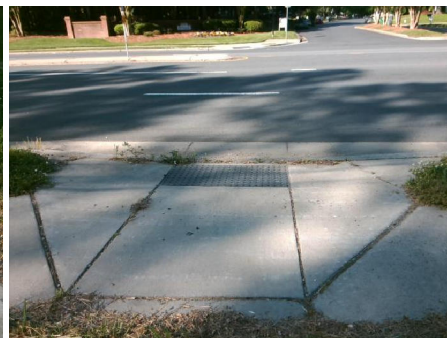
Compliance	Description	Data	Compliance	Description	Data
N/A	Ramp Length (in)	88.0	Yes	Ramp Slope (%)	5.1
No	Ramp Width (in)	47.0	Yes	Ramp XSlope (%)	0.7
N/A	Flare Type LT	N/A	N/A	Flare Type RT	N/A
N/A	Flare Slope LT (%)	N/A	N/A	Flare Slope RT (%)	N/A
N/A	Flare Traversable LT?	N/A	N/A	Flare Traversable RT?	N/A
N/A	Landing Length (in)	N/A	N/A	DWS Provided?	N/A
N/A	Landing Width (in)	N/A	N/A	DWS Contrast?	N/A
N/A	Landing Slope (%)	N/A	N/A	DWS Length (in)	N/A
N/A	Landing X Slope (%)	N/A	N/A	DWS Full Width?	N/A
N/A	Landing Curb? (Y/N)	N/A	N/A	DWS Offset (in)	N/A
N/A	Shared Landing?	N/A			
N/A	Gutter Ponding?	N/A	N/A	Gutter Slope (%)	N/A
N/A	Gutter Lip Ht (in)	N/A	N/A	Gutter X Slope (%)	N/A
N/A	Painted X Walk1?	No	N/A	Painted X Walk2?	N/A
	X Walk 1 Direction	To SW		X Walk 2 Direction	N/A
N/A	X Walk 1 Width (in)	N/A	N/A	X Walk 2 Width (in)	N/A
	X Walk 1 Slope (%)	0.2		X Walk 2 Slope (%)	N/A
	X Walk 1 X Slope (%)	0.9		X Walk 2 X Slope (%)	N/A

N/A	Ramp inside XWalk1?	N/A	N/A	Ramp inside XWalk2?	N/A
	Road Slope (%)	N/A	N/A	Clear Space?	N/A
	Road X Slope (%)	N/A	N/A	Clear Space to XWalk (in)	N/A
N/A	Any Obstructions?	N/A	N/A	Storm Grate/Utility Hazard?	N/A
	Obstruction Type			Storm Grate/Utility Type	
		N/A			N/A
			Yes	Surface Condition? (G/P)	Good

Possible Solutions:

Remove & Replace Entire Ramp.
