Access Compliance Report

Public Rights-of-Way

(Curb Ramps)

Intersection ID: 5654	Main Street: JOHN_KIRK_DR	Cross Street: JOHN_KIRK_DR	Location: NW
ADA ID: E21AA5514840	Ramp Type: BlendTrans1	Initial Pass/Fail: Fail	Overall Compliance: No
		Severity Score: 1.25

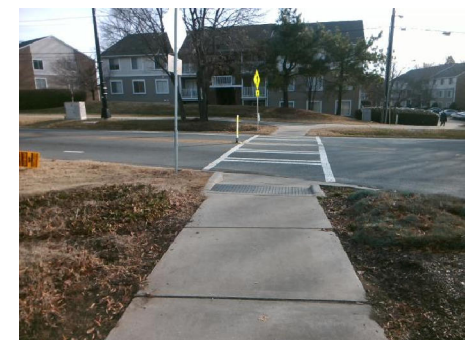
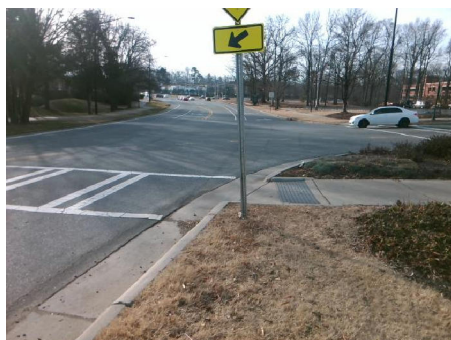
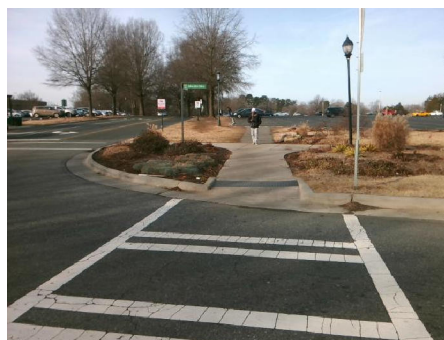
Compliance	Description	Data	Compliance	Description	Data
N/A	Ramp Length (in)	38.0	Yes	BlendTrans Slope (%)	3.9
Yes	Ramp Width (in)	71.0	No	BlendTrans XSlope (%)	2.4
N/A	Flare Type LT	N/A	N/A	Flare Type RT	N/A
N/A	Flare Slope LT (%)	N/A	N/A	Flare Slope RT (%)	N/A
N/A	Flare Traversable LT?	N/A	N/A	Flare Traversable RT?	N/A
N/A	Landing Length (in)	N/A	N/A	DWS Provided?	N/A
N/A	Landing Width (in)	N/A	N/A	DWS Contrast?	N/A
N/A	Landing Slope (%)	N/A	N/A	DWS Length (in)	N/A
N/A	Landing X Slope (%)	N/A	N/A	DWS Full Width?	N/A
N/A	Landing Curb? (Y/N)	N/A	N/A	DWS Offset (in)	N/A
N/A	Shared Landing?	N/A			
N/A	Gutter Ponding?	N/A	N/A	Gutter Slope (%)	N/A
N/A	Gutter Lip Ht (in)	N/A	N/A	Gutter X Slope (%)	N/A
N/A	Painted X Walk1?	Yes	N/A	Painted X Walk2?	N/A
	X Walk 1 Direction	To E		X Walk 2 Direction	N/A
	X Walk 1 Width (in)	108.0		X Walk 2 Width (in)	N/A
	X Walk 1 Slope (%)	0.1		X Walk 2 Slope (%)	N/A
	X Walk 1 X Slope (%)	2.2		X Walk 2 X Slope (%)	N/A

N/A	Ramp inside XWalk1?	Yes	N/A	Ramp inside XWalk2?	N/A
	Road Slope (%)	2.2		Clear Space?	N/A
	Road X Slope (%)	0.1	N/A	Clear Space to XWalk (in)	N/A
N/A	Any Obstructions?	N/A	N/A	Storm Grate/Utility Hazard?	N/A
	Obstruction Type			Storm Grate/Utility Type	
		N/A			N/A
			Yes	Surface Condition? (G/P)	Good
			No	Curb Slope (%)	7.0

Remove & Replace Curb Ramp With Two New Directional Ramps or Equivalent.
