Access Compliance Report

Public Rights-of-Way

(Curb Ramps)

Intersection ID: N/A	Main Street: PROVIDENCE_RD	Cross Street: N/A	Location: NE
ADA ID: E2262CFF2E53	Ramp Type: PerpDiag	Initial Pass/Fail: Pass	Overall Compliance: No
			Severity Score: 10.25

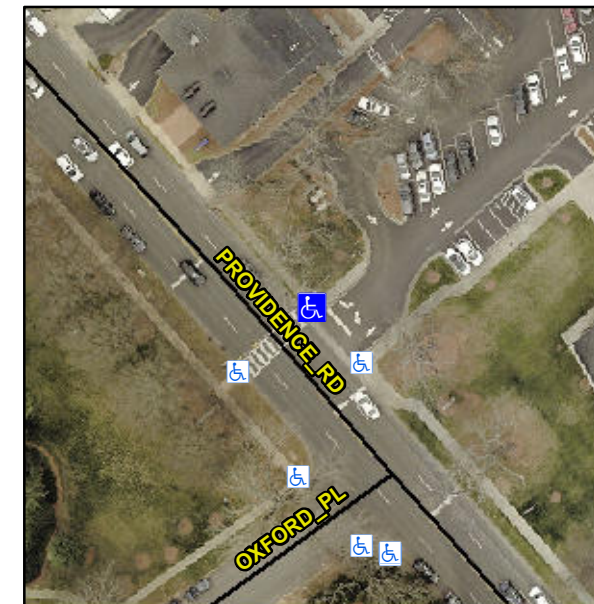
Compliance	Description	Data	Compliance	Description	Data
N/A	Ramp Length (in)	60.0	Yes	Ramp Slope (%)	7.9
Yes	Ramp Width (in)	48.0	No	Ramp XSlope (%)	3.3
N/A	Flare Type LT	Sloped	N/A	Flare Type RT	N/A
N/A	Flare Slope LT (%)	0.4	Yes	Flare Slope RT (%)	0.3
N/A	Flare Traversable LT?	Yes	N/A	Flare Traversable RT?	Yes
No	Landing Length (in)	N/A	Yes	DWS Provided?	Yes
No	Landing Width (in)	N/A	Yes	DWS Contrast?	Yes
No	Landing Slope (%)	N/A	Yes	DWS Length (in)	24.5
No	Landing X Slope (%)	N/A	Yes	DWS Full Width?	Yes
N/A	Landing Curb? (Y/N)	No	No	DWS Offset (in)	3.0
N/A	Shared Landing?	N/A			
Yes	Gutter Ponding?	No	Yes	Gutter Slope (%)	1.4
Yes	Gutter Lip Ht (in)	0.0	Yes	Gutter X Slope (%)	1.7
N/A	Painted X Walk1?	Yes	N/A	Painted X Walk2?	No
	X Walk 1 Direction	To SW		X Walk 2 Direction	To SE
N/A	X Walk 1 Width (in)	110.0	N/A	X Walk 2 Width (in)	N/A
	X Walk 1 Slope (%)	0.1		X Walk 2 Slope (%)	1.6
	X Walk 1 X Slope (%)	1.3		X Walk 2 X Slope (%)	0.9

Yes	Ramp inside XWalk1?	Yes	N/A	Ramp inside XWalk2?	N/A
	Road Slope (%)	1.4	N/A	Clear Space?	Yes
	Road X Slope (%)	1.3	N/A	Clear Space to XWalk (in)	N/A
Yes	Any Obstructions?	No	Yes	Storm Grate/Utility Hazard?	No
	Obstruction Type			Storm Grate/Utility Type	
		N/A			N/A
			Yes	Surface Condition? (G/P)	Good

Remove & Replace Curb Ramp With Two New Directional Ramps or Equivalent.
