Access Compliance Report

Public Rights-of-Way

(Curb Ramps)

Intersection ID: N/A	Main Street: KIRKWYND COMMONS DR	Cross Street: SHETLAND LN	Location: NW
ADA ID: E2280441BAE7	Ramp Type: PerpDiag	Initial Pass/Fail: Fail	Overall Compliance: No
Codes/Mitigation Info/Possible Solution		Field Measurements/Component Compliance

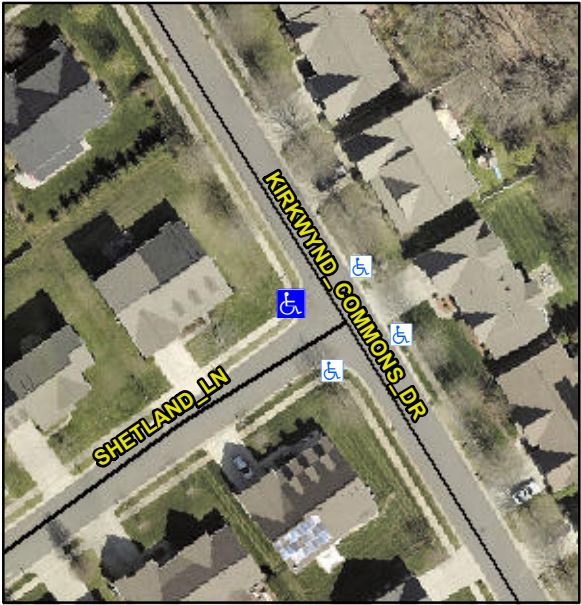
Possible Solutions:						
	Remove & Replace Curb Ramp With Two New Directional Ramps or Equivalent.	Compliance	Description	Data	Compliance	Description	Data
<p>Surveyor Notes:</p> <p>N/A</p> <p>PROW/ADA:</p> <p>Not Found, R304.2.2, R304.5.3</p>		N/A	Ramp Length (in)	45.0	No	Ramp Slope (%)	10.8
		Yes	Ramp Width (in)	48.0	No	Ramp XSlope (%)	4.2
<p>Total Cost:</p> <p>\$ 3200.00</p>		N/A	Flare Type LT	N/A	N/A	Flare Type RT	N/A
		N/A	Flare Slope LT (%)	N/A	N/A	Flare Slope RT (%)	N/A
		N/A	Flare Traversable LT?	N/A	N/A	Flare Traversable RT?	N/A
		N/A	Landing Length (in)	N/A	N/A	DWS Provided?	N/A
		N/A	Landing Width (in)	N/A	N/A	DWS Contrast?	N/A
		N/A	Landing Slope (%)	N/A	N/A	DWS Length (in)	N/A
		N/A	Landing X Slope (%)	N/A	N/A	DWS Full Width?	N/A
		N/A	Landing Curb? (Y/N)	N/A	N/A	DWS Offset (in)	N/A
		N/A	Shared Landing?	N/A			
		N/A	Gutter Ponding?	N/A	N/A	Gutter Slope (%)	N/A
		N/A	Gutter Lip Ht (in)	N/A	N/A	Gutter X Slope (%)	N/A

N/A	Painted X Walk1?	No	N/A	Painted X Walk2?	No
			X Walk 1 Direction	To SE		X Walk 2 Direction	To NE
		N/A	X Walk 1 Width (in)	N/A	N/A	X Walk 2 Width (in)	N/A
			X Walk 1 Slope (%)	2.9		X Walk 2 Slope (%)	1.4
			X Walk 1 X Slope (%)	2.3		X Walk 2 X Slope (%)	2.8
		N/A	Ramp inside XWalk1?	N/A	N/A	Ramp inside XWalk2?	N/A
			Road Slope (%)	4.8	N/A	Clear Space?	N/A
			Road X Slope (%)	2.3	N/A	Clear Space to XWalk (in)	N/A
		N/A	Any Obstructions?	N/A	N/A	Storm Grate/Utility Hazard?	N/A
			Obstruction Type			Storm Grate/Utility Type	
				N/A			N/A
					Yes	Surface Condition? (G/P)	Good
