# Access Compliance Report

## Public Rights-of-Way

### (Curb Ramps)

Intersection ID: 14315	Main Street: DRIFTWOOD_DR	Cross Street: ROSEHAVEN_DR	Location: S
ADA ID: E22A5F310971	Ramp Type: PerpDiag	Initial Pass/Fail: Fail	Overall Compliance: No
		Severity Score: 12.5

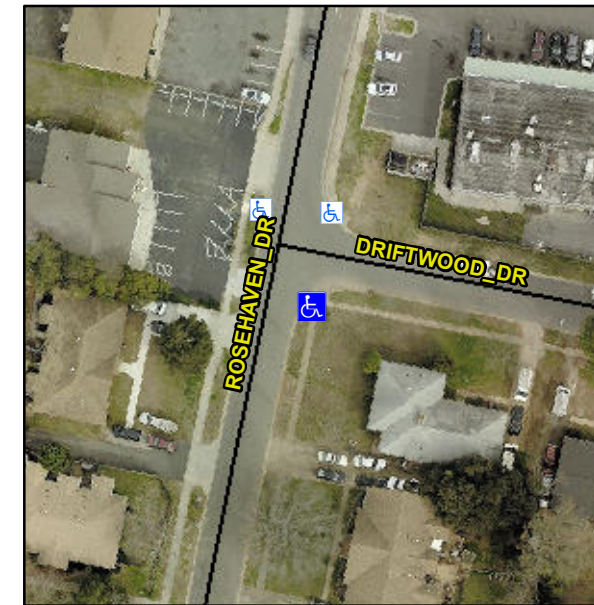
**Not Found, R304.2.2**

Compliance	Description	Data	Compliance	Description	Data
N/A	Ramp Length (in)	61.0	No	Ramp Slope (%)	8.4
Yes	Ramp Width (in)	48.0	Yes	Ramp XSlope (%)	0.8
N/A	Flare Type LT	N/A	N/A	Flare Type RT	N/A
N/A	Flare Slope LT (%)	N/A	N/A	Flare Slope RT (%)	N/A
N/A	Flare Traversable LT?	N/A	N/A	Flare Traversable RT?	N/A
N/A	Landing Length (in)	N/A	N/A	DWS Provided?	N/A
N/A	Landing Width (in)	N/A	N/A	DWS Contrast?	N/A
N/A	Landing Slope (%)	N/A	N/A	DWS Length (in)	N/A
N/A	Landing X Slope (%)	N/A	N/A	DWS Full Width?	N/A
N/A	Landing Curb? (Y/N)	N/A	N/A	DWS Offset (in)	N/A
N/A	Shared Landing?	N/A			
N/A	Gutter Ponding?	N/A	N/A	Gutter Slope (%)	N/A
N/A	Gutter Lip Ht (in)	N/A	N/A	Gutter X Slope (%)	N/A
N/A	Painted X Walk1?	No	N/A	Painted X Walk2?	No
	X Walk 1 Direction	To N		X Walk 2 Direction	To W
N/A	X Walk 1 Width (in)	N/A	N/A	X Walk 2 Width (in)	N/A
	X Walk 1 Slope (%)	0.2		X Walk 2 Slope (%)	0.5
	X Walk 1 X Slope (%)	0.4		X Walk 2 X Slope (%)	0.0

N/A	Ramp inside XWalk1?	N/A	N/A	Ramp inside XWalk2?	N/A
	Road Slope (%)	0.3	N/A	Clear Space?	N/A
	Road X Slope (%)	0.5	N/A	Clear Space to XWalk (in)	N/A
N/A	Any Obstructions?	N/A	N/A	Storm Grate/Utility Hazard?	N/A
	Obstruction Type			Storm Grate/Utility Type	
		N/A			N/A
		Yes		Surface Condition? (G/P)	Good

**Remove & Replace Curb Ramp With Two New Directional Ramps or Equivalent.**

Total Cost: \$ 3200.00
