Access Compliance Report

Public Rights-of-Way

(Curb Ramps)

Intersection ID: 53758	Main Street: PROSPERITY RIDGE RD	Cross Street: JOHNSTON OEHLER RD	Location:	N
ADA ID: E241F88C7594	Ramp Type: Perp	Initial Pass/Fail: Fail	Overall Compliance: No	Severity Score: 12.5
Codes/Mitigation Info/Possible Solution		Field Measurements/Component Compliance

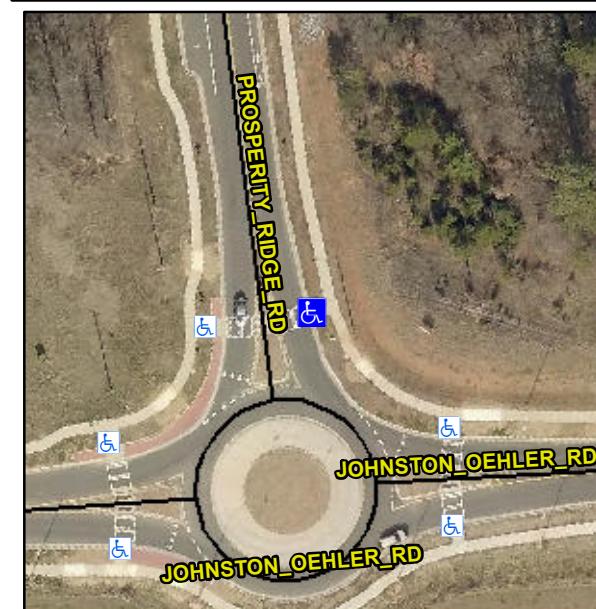
Compliance	Description	Data	Compliance	Description	Data
N/A	Ramp Length (in)	94.5	No	Ramp Slope (%)	8.9
Yes	Ramp Width (in)	69.0	Yes	Ramp XSlope (%)	1.7
N/A	Flare Type LT	N/A	N/A	Flare Type RT	N/A
N/A	Flare Slope LT (%)	N/A	N/A	Flare Slope RT (%)	N/A
N/A	Flare Traversable LT?	N/A	N/A	Flare Traversable RT?	N/A
N/A	Landing Length (in)	N/A	N/A	DWS Provided?	N/A
N/A	Landing Width (in)	N/A	N/A	DWS Contrast?	N/A
N/A	Landing Slope (%)	N/A	N/A	DWS Length (in)	N/A
N/A	Landing X Slope (%)	N/A	N/A	DWS Full Width?	N/A
N/A	Landing Curb? (Y/N)	N/A	N/A	DWS Offset (in)	N/A
N/A	Shared Landing?	N/A			
N/A	Gutter Ponding?	N/A	N/A	Gutter Slope (%)	N/A
N/A	Gutter Lip Ht (in)	N/A	N/A	Gutter X Slope (%)	N/A
N/A	Painted X Walk1?	Yes	N/A	Painted X Walk2?	N/A
	X Walk 1 Direction	To W		X Walk 2 Direction	N/A
N/A	X Walk 1 Width (in)	111.5	N/A	X Walk 2 Width (in)	N/A
	X Walk 1 Slope (%)	1.4		X Walk 2 Slope (%)	N/A
	X Walk 1 X Slope (%)	2.1		X Walk 2 X Slope (%)	N/A

N/A	Ramp inside XWalk1?	Yes	N/A	Ramp inside XWalk2?	N/A
	Road Slope (%)	N/A	N/A	Clear Space?	N/A
	Road X Slope (%)	N/A	N/A	Clear Space to XWalk (in)	N/A
N/A	Any Obstructions?	N/A	N/A	Storm Grate/Utility Hazard?	N/A
	Obstruction Type			Storm Grate/Utility Type	
		N/A			N/A
			Yes	Surface Condition? (G/P)	Good

Possible Solutions:

Remove & Replace Entire Ramp.

PROW/ADA:

R304.2.2
