# Access Compliance Report

## Public Rights-of-Way

### (Curb Ramps)

Intersection ID: 14883	Main Street: CIRCLE_AV	Cross Street: HERMITAGE_CT	Location: SE
ADA ID: E24C8E87F7C7	Ramp Type: PerpDiag	Initial Pass/Fail: Fail	Overall Compliance: No
Severity Score: 21.25			
Codes/Mitigation Info/Possible Solution		Field Measurements/Component Compliance

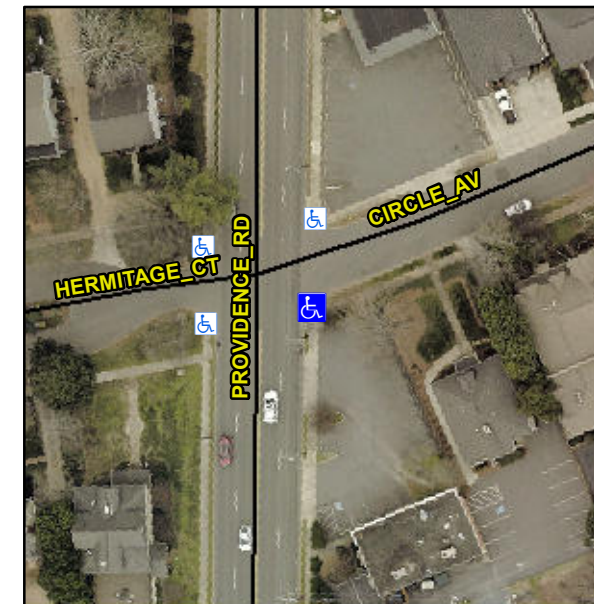
**Not Found, R304.5.1, R304.2.2**

Compliance	Description	Data	Compliance	Description	Data
N/A	Ramp Length (in)	36.0	No	Ramp Slope (%)	11.5
No	Ramp Width (in)	39.0	Yes	Ramp XSlope (%)	0.2
N/A	Flare Type LT	N/A	N/A	Flare Type RT	N/A
N/A	Flare Slope LT (%)	N/A	N/A	Flare Slope RT (%)	N/A
N/A	Flare Traversable LT?	N/A	N/A	Flare Traversable RT?	N/A
N/A	Landing Length (in)	N/A	N/A	DWS Provided?	N/A
N/A	Landing Width (in)	N/A	N/A	DWS Contrast?	N/A
N/A	Landing Slope (%)	N/A	N/A	DWS Length (in)	N/A
N/A	Landing X Slope (%)	N/A	N/A	DWS Full Width?	N/A
N/A	Landing Curb? (Y/N)	N/A	N/A	DWS Offset (in)	N/A
N/A	Shared Landing?	N/A			
N/A	Gutter Ponding?	N/A	N/A	Gutter Slope (%)	N/A
N/A	Gutter Lip Ht (in)	N/A	N/A	Gutter X Slope (%)	N/A
N/A	Painted X Walk1?	No	N/A	Painted X Walk2?	No
	X Walk 1 Direction	To N		X Walk 2 Direction	To W
N/A	X Walk 1 Width (in)	N/A	N/A	X Walk 2 Width (in)	N/A
	X Walk 1 Slope (%)	1.4		X Walk 2 Slope (%)	3.1
	X Walk 1 X Slope (%)	1.8		X Walk 2 X Slope (%)	0.9

N/A	Ramp inside XWalk1?	N/A	N/A	Ramp inside XWalk2?	N/A
	Road Slope (%)	0.8	N/A	Clear Space?	N/A
	Road X Slope (%)	1.0	N/A	Clear Space to XWalk (in)	N/A
N/A	Any Obstructions?	N/A	N/A	Storm Grate/Utility Hazard?	N/A
	Obstruction Type			Storm Grate/Utility Type	
		N/A			N/A
		Yes		Surface Condition? (G/P)	Good

**Remove & Replace Curb Ramp With Two New Directional Ramps or Equivalent.**
