# Access Compliance Report

## Public Rights-of-Way

### (Curb Ramps)

| Intersection ID: 46753 | Main Street: HAVASU_ST | Cross Street: CUMBERLAND_COVE_DR | Location: NW |

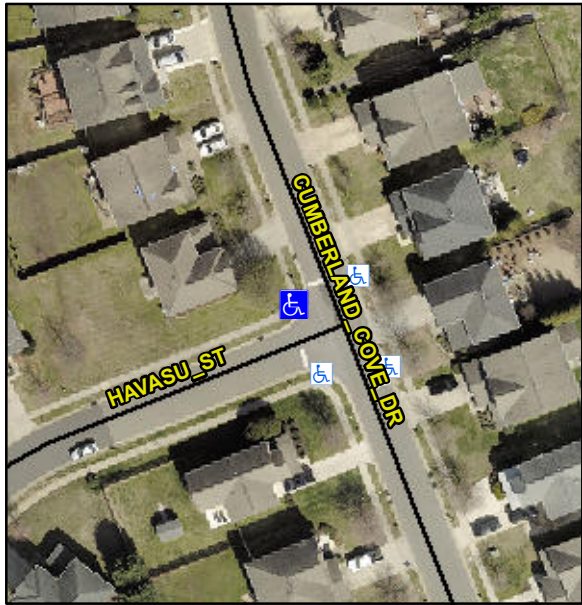
| ADA ID: E2545BF06682 | Ramp Type: PerpDiag | Initial Pass/Fail: Fail | Overall Compliance: No |

| Codes/Mitigation Info/Possible Solution | | Field Measurements/Component Compliance | | | | | | |
|---|---|---|---|---|---|---|---|---|
| | <b>Remove &amp; Replace Curb Ramp With Two New Directional Ramps or Equivalent.</b> | | N/A | Ramp Length (in) | 47.0 | No | Ramp Slope (%) | 11.5 |
| | | | No | Ramp Width (in) | 33.0 | Yes | Ramp XSlope (%) | 1.9 |
| PROW/ADA:<br><br><b>R304.5.1, R304.2.2</b> | | N/A | Shared Landing? | N/A | | | | |
