Access Compliance Report

Public Rights-of-Way

(Curb Ramps)

Intersection ID: 28390	Main Street: ARDREY_KELL_RD	Cross Street: BRIDGEHAMPTON_CLUB_DR	Location: SW
ADA ID: E2664F93E6EB	Ramp Type: Perp	Initial Pass/Fail: Fail	Overall Compliance: No
		Severity Score: 12.5

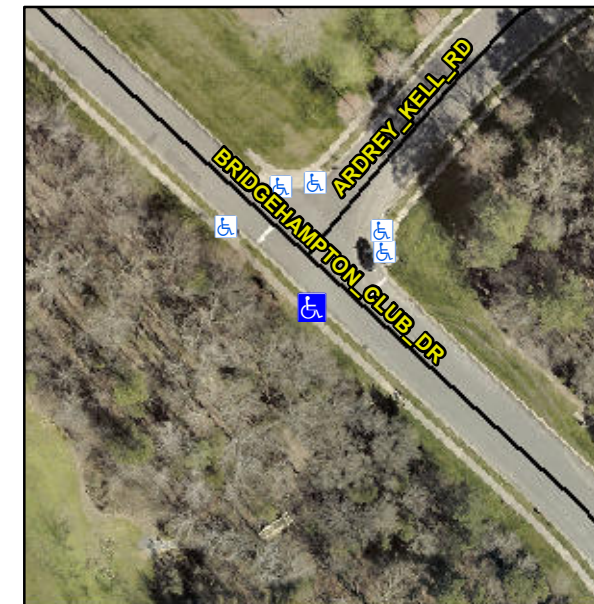
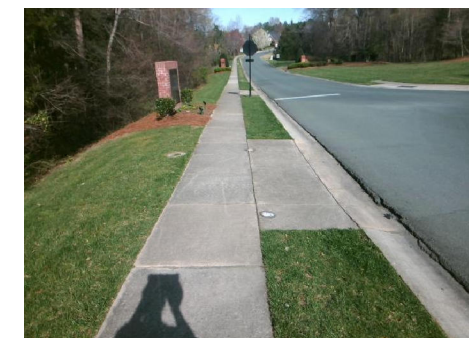
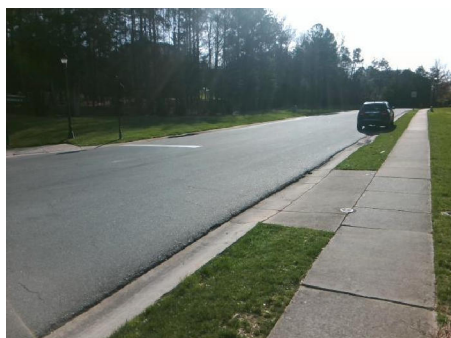
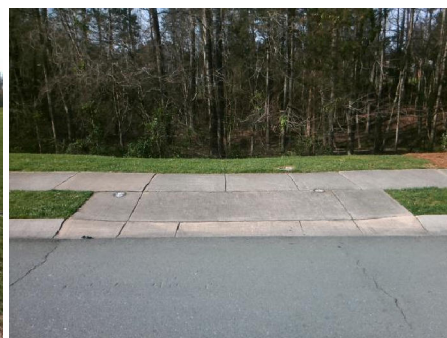
Not Found, R304.2.2

Compliance	Description	Data	Compliance	Description	Data
N/A	Ramp Length (in)	46.0	No	Ramp Slope (%)	8.6
Yes	Ramp Width (in)	133.5	Yes	Ramp XSlope (%)	0.8
N/A	Flare Type LT	N/A	N/A	Flare Type RT	N/A
N/A	Flare Slope LT (%)	N/A	N/A	Flare Slope RT (%)	N/A
N/A	Flare Traversable LT?	N/A	N/A	Flare Traversable RT?	N/A
N/A	Landing Length (in)	N/A	N/A	DWS Provided?	N/A
N/A	Landing Width (in)	N/A	N/A	DWS Contrast?	N/A
N/A	Landing Slope (%)	N/A	N/A	DWS Length (in)	N/A
N/A	Landing X Slope (%)	N/A	N/A	DWS Full Width?	N/A
N/A	Landing Curb? (Y/N)	N/A	N/A	DWS Offset (in)	N/A
N/A	Shared Landing?	N/A			
N/A	Gutter Ponding?	N/A	N/A	Gutter Slope (%)	N/A
N/A	Gutter Lip Ht (in)	3.0	N/A	Gutter X Slope (%)	N/A
N/A	Painted X Walk1?	No	N/A	Painted X Walk2?	N/A
	X Walk 1 Direction	To NE		X Walk 2 Direction	N/A
N/A	X Walk 1 Width (in)	N/A	N/A	X Walk 2 Width (in)	N/A
	X Walk 1 Slope (%)	1.9		X Walk 2 Slope (%)	N/A
	X Walk 1 X Slope (%)	2.7		X Walk 2 X Slope (%)	N/A

Remove & Replace Entire Ramp.
