# Access Compliance Report

## Public Rights-of-Way

### (Curb Ramps)

Intersection ID: 49136	Main Street: AMBER_LEIGH_WAY_DR	Cross Street: POPE_FARM_RD	Location:	N
ADA ID: E26A3020E25D	Ramp Type: Perp	Initial Pass/Fail: Fail	Overall Compliance: No	Severity Score: 1.25
Codes/Mitigation Info/Possible Solution		Field Measurements/Component Compliance

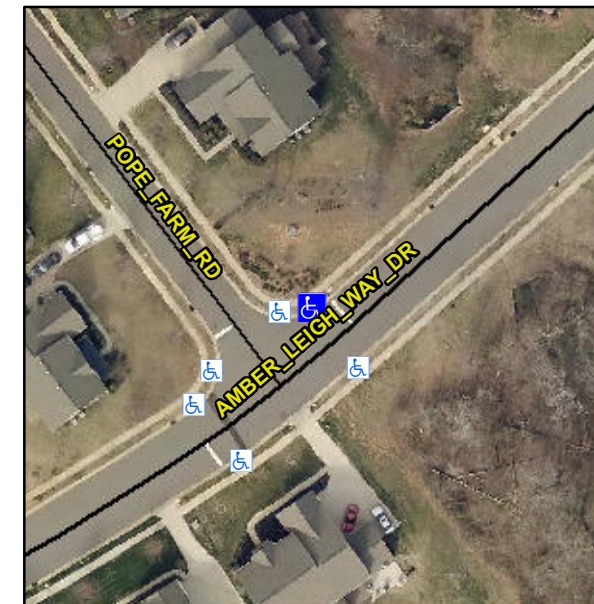
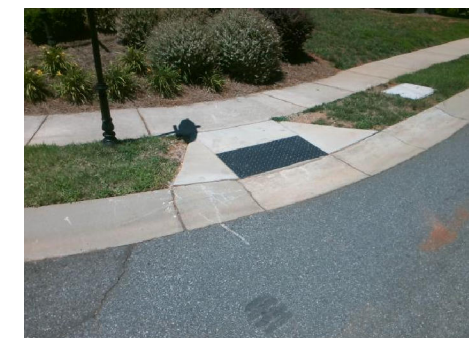
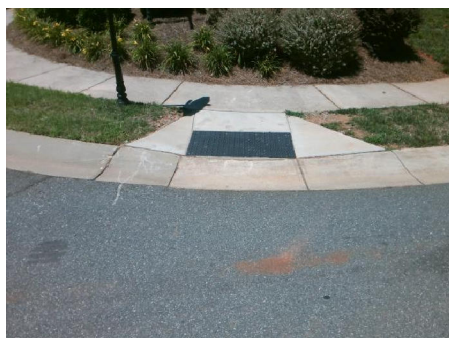
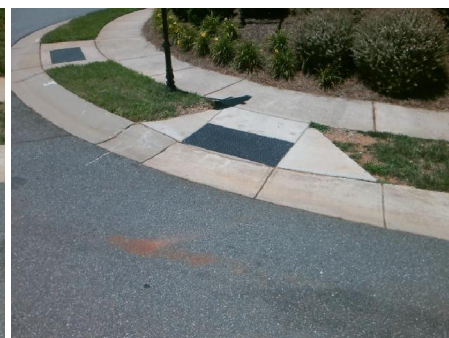
Compliance	Description	Data	Compliance	Description	Data
N/A	Ramp Length (in)	48.0	Yes	Ramp Slope (%)	7.6
Yes	Ramp Width (in)	48.5	No	Ramp XSlope (%)	4.1
N/A	Flare Type LT	N/A	N/A	Flare Type RT	N/A
N/A	Flare Slope LT (%)	N/A	N/A	Flare Slope RT (%)	N/A
N/A	Flare Traversable LT?	N/A	N/A	Flare Traversable RT?	N/A
N/A	Landing Length (in)	N/A	N/A	DWS Provided?	N/A
N/A	Landing Width (in)	N/A	N/A	DWS Contrast?	N/A
N/A	Landing Slope (%)	N/A	N/A	DWS Length (in)	N/A
N/A	Landing X Slope (%)	N/A	N/A	DWS Full Width?	N/A
N/A	Landing Curb? (Y/N)	N/A	N/A	DWS Offset (in)	N/A
N/A	Shared Landing?	N/A			
N/A	Gutter Ponding?	N/A	N/A	Gutter Slope (%)	N/A
N/A	Gutter Lip Ht (in)	N/A	N/A	Gutter X Slope (%)	N/A
N/A	Painted X Walk1?	No	N/A	Painted X Walk2?	N/A
	X Walk 1 Direction	To SE		X Walk 2 Direction	N/A
N/A	X Walk 1 Width (in)	N/A	N/A	X Walk 2 Width (in)	N/A
	X Walk 1 Slope (%)	4.9		X Walk 2 Slope (%)	N/A
	X Walk 1 X Slope (%)	3.2		X Walk 2 X Slope (%)	N/A

N/A	Ramp inside XWalk1?	N/A	N/A	Ramp inside XWalk2?	N/A
	Road Slope (%)	N/A	N/A	Clear Space?	N/A
	Road X Slope (%)	N/A	N/A	Clear Space to XWalk (in)	N/A
N/A	Any Obstructions?	N/A	N/A	Storm Grate/Utility Hazard?	N/A
	Obstruction Type			Storm Grate/Utility Type	
		N/A			N/A
			Yes	Surface Condition? (G/P)	Good

**Remove & Replace Entire Ramp.**

**R304.5.3**

**\$ 1850.00**
