# Access Compliance Report

## Public Rights-of-Way

### (Curb Ramps)

| Intersection ID: 28385 | Main Street: COMMONS_CROSSING_DR | Cross Street: HIGHLANDS_CROSSING_DR | Location: SW |

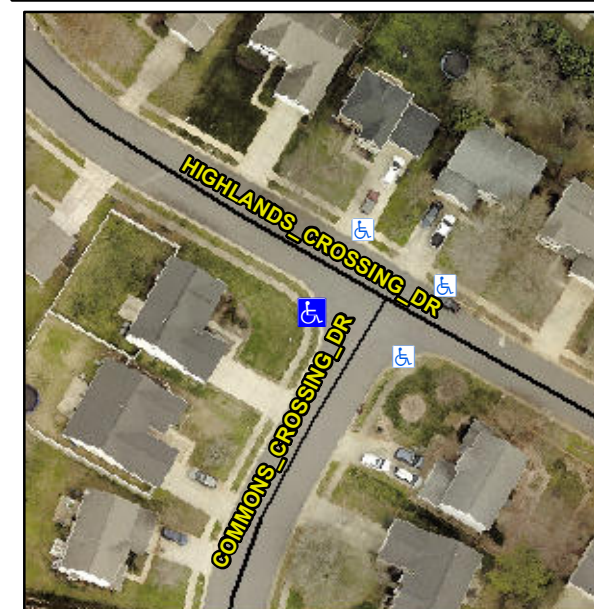
**Not Found, R304.2.1, R304.2.2-Perp, R304.3.2-Para, R305, R302.7.2, R304.5.4**

| Compliance | Description | Data | Compliance | Description | Data |
|---|---|---|---|---|---|
| No | Landing Length (in) | 47.0 | No | DWS Provided? | No |
| No | Landing Slope (%) | 2.6 | N/A | DWS Length (in) | N/A |
| Yes | Gutter Ponding? | No | No | Gutter Slope (%) | 9.9 |
| No | Gutter Lip Ht (in) | 0.5 | Yes | Gutter X Slope (%) | 0.7 |

**Remove & Replace Curb Ramp With Two New Directional Ramps or Equivalent. Remove & Replace Gutter.**

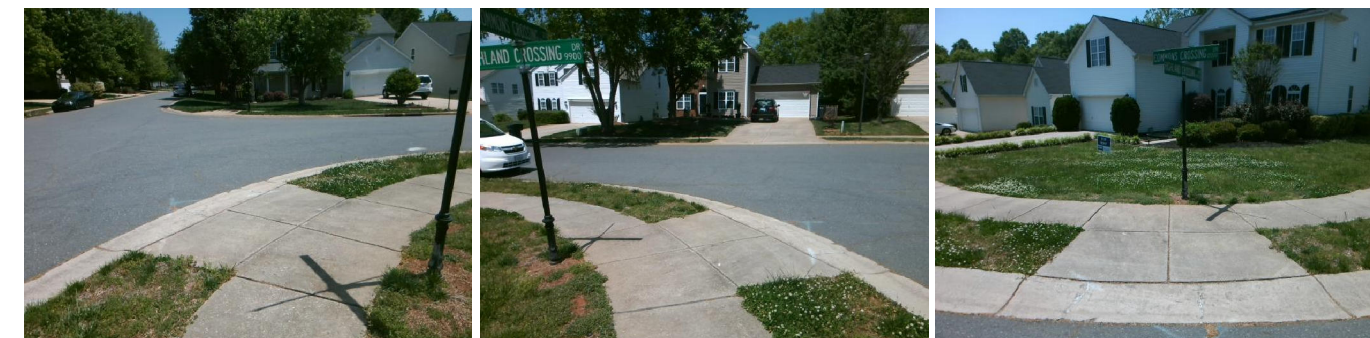
Street 1 Name COMMONS CROSSING DR  
 Stop Condition-Street 2 StopSign  
 Street 2 Name HIGHLANDS CROSSING DR  
 Stop Condition-Street 1 None
