Access Compliance Report Public Rights-of-Way (Curb Ramps)

Intersection ID: 10022821 Main Street: CASTLE WATCH AV **Cross Street: N/A** Location: NW

Overall Compliance: No ADA ID: E2700CB1F13D Ramp Type: PerpDiag Initial Pass/Fail: Fail Severity Score: 33.75

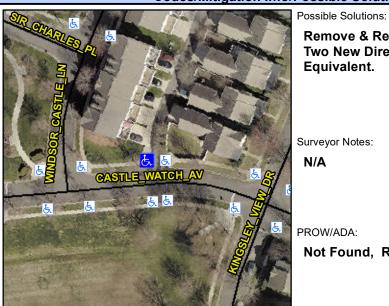
Compliance Description		Data	Comp	oliance Description	Data
N/A	Ramp Length (in)	76.0	Yes	Ramp Slope (%)	5.8
No	Ramp Width (in)	39.0	No	Ramp XSlope (%)	7.8
N/A	Flare Type LT	N/A	N/A	Flare Type RT	N/A
N/A	Flare Slope LT (%)	N/A	N/A	Flare Slope RT (%)	N/A
N/A	Flare Traversable LT?	N/A	N/A	Flare Traversable RT?	N/A
N/A	Landing Length (in)	N/A	N/A	DWS Provided?	N/A
N/A	Landing Width (in)	N/A	N/A	DWS Contrast?	N/A
N/A	Landing Slope (%)	N/A	N/A	DWS Length (in)	N/A
N/A	Landing X Slope (%)	N/A	N/A	DWS Full Width?	N/A
N/A	Landing Curb? (Y/N)	N/A	N/A	DWS Offset (in)	N/A
N/A	Shared Landing?	N/A			
N/A	Gutter Ponding?	N/A	N/A	Gutter Slope (%)	N/A
N/A	Gutter Lip Ht (in)	N/A	N/A	Gutter X Slope (%)	N/A
N/A	Painted X Walk1?	No	N/A	Painted X Walk2?	No
	X Walk 1 Direction	To S		X Walk 2 Direction	To E
N/A	X Walk 1 Width (in)	N/A	N/A	X Walk 2 Width (in)	N/A
	X Walk 1 Slope (%)	0.4		X Walk 2 Slope (%)	2.8
	X Walk 1 X Slope (%)	3.3		X Walk 2 X Slope (%)	2.7

N/A	Ramp inside XWalk1?	N/A	N/A	Ramp inside XWalk2?	N/A
	Road Slope (%)	3.0	N/A	Clear Space?	N/A
	Road X Slope (%)	4.8	N/A	Clear Space to XWalk (in)	N/A
N/A	Any Obstructions?	N/A	N/A	Storm Grate/Utility Hazard?	N/A
	Obstruction Type			Storm Grate/Utility Type	
		N/A			N/A
			Yes	Surface Condition? (G/P)	Good

CASTLE WATCH AV Street 1 Name Stop Condition-Street 2 None Street 2 Name N/A Stop Condition-Street 1 None Remove & Replace Curb Ramp With Two New Directional Ramps or Equivalent.

or Notes:				N/A
				N/A
ADA:				N/A
Found,	R304.5.1, R304	.5.3		N/A
	·			N/A
				N/A
				N/A
				N/A
ost:		\$	3200.00
