Access Compliance Report

Public Rights-of-Way (Curb Ramps)

Intersection ID: 45891	Main Street: PROSPERITY_CHURCH_RD	Cross Street: STONE_PARK_DR	Location: SW
ADA ID: E27229311E77	Ramp Type: PerpDiag	Initial Pass/Fail: Fail	Overall Compliance: No
Severity Score: 8.75			
Codes/Mitigation Info/Possible Solution		Field Measurements/Component Compliance

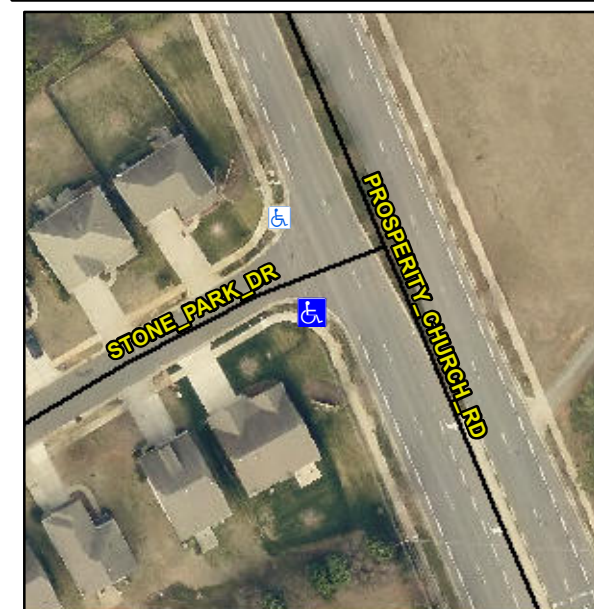
Not Found, R304.5.1

Compliance	Description	Data	Compliance	Description	Data
N/A	Ramp Length (in)	72.5	Yes	Ramp Slope (%)	7.7
No	Ramp Width (in)	36.5	Yes	Ramp XSlope (%)	1.3
N/A	Flare Type LT	N/A	N/A	Flare Type RT	N/A
N/A	Flare Slope LT (%)	N/A	N/A	Flare Slope RT (%)	N/A
N/A	Flare Traversable LT?	N/A	N/A	Flare Traversable RT?	N/A
N/A	Landing Length (in)	N/A	N/A	DWS Provided?	N/A
N/A	Landing Width (in)	N/A	N/A	DWS Contrast?	N/A
N/A	Landing Slope (%)	N/A	N/A	DWS Length (in)	N/A
N/A	Landing X Slope (%)	N/A	N/A	DWS Full Width?	N/A
N/A	Landing Curb? (Y/N)	N/A	N/A	DWS Offset (in)	N/A
N/A	Shared Landing?	N/A			
N/A	Gutter Ponding?	N/A	N/A	Gutter Slope (%)	N/A
N/A	Gutter Lip Ht (in)	N/A	N/A	Gutter X Slope (%)	N/A
N/A	Painted X Walk1?	No	N/A	Painted X Walk2?	No
	X Walk 1 Direction	To E		X Walk 2 Direction	To N
N/A	X Walk 1 Width (in)	N/A	N/A	X Walk 2 Width (in)	N/A
	X Walk 1 Slope (%)	2.0		X Walk 2 Slope (%)	1.7
	X Walk 1 X Slope (%)	1.3		X Walk 2 X Slope (%)	1.3

N/A	Ramp inside XWalk1?	N/A	N/A	Ramp inside XWalk2?	N/A
	Road Slope (%)	1.9	N/A	Clear Space?	N/A
	Road X Slope (%)	0.5	N/A	Clear Space to XWalk (in)	N/A
N/A	Any Obstructions?	N/A	N/A	Storm Grate/Utility Hazard?	N/A
	Obstruction Type			Storm Grate/Utility Type	
		N/A			N/A
		Yes		Surface Condition? (G/P)	Good

Remove & Replace Curb Ramp With Two New Directional Ramps or Equivalent.

Total Cost: \$ 3200.00
