Access Compliance Report

Public Rights-of-Way

(Curb Ramps)

Intersection ID: 9281	Main Street: ORCHID_BLOSSOM_LN	Cross Street: WESTERWOOD_VILLAGE_DR	Location:	N
ADA ID: E27C01CECBDB	Ramp Type: BlendTrans1	Initial Pass/Fail: Fail	Overall Compliance: No	Severity Score: 10
Codes/Mitigation Info/Possible Solution		Field Measurements/Component Compliance

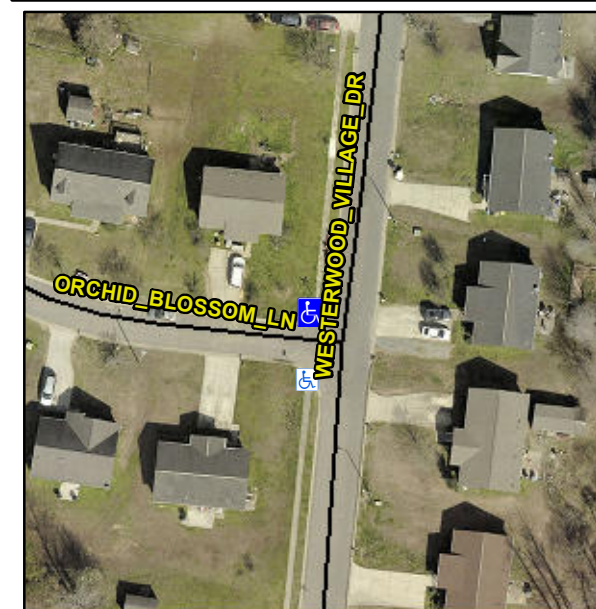
R304.5.1, R304.5.3

Compliance	Description	Data	Compliance	Description	Data
N/A	Ramp Length (in)	28.0	Yes	BlendTrans Slope (%)	3.0
No	Ramp Width (in)	47.5	No	BlendTrans XSlope (%)	2.1
N/A	Flare Type LT	N/A	N/A	Flare Type RT	N/A
N/A	Flare Slope LT (%)	N/A	N/A	Flare Slope RT (%)	N/A
N/A	Flare Traversable LT?	N/A	N/A	Flare Traversable RT?	N/A
N/A	Landing Length (in)	N/A	N/A	DWS Provided?	N/A
N/A	Landing Width (in)	N/A	N/A	DWS Contrast?	N/A
N/A	Landing Slope (%)	N/A	N/A	DWS Length (in)	N/A
N/A	Landing X Slope (%)	N/A	N/A	DWS Full Width?	N/A
N/A	Landing Curb? (Y/N)	N/A	N/A	DWS Offset (in)	N/A
N/A	Shared Landing?	N/A			
N/A	Gutter Ponding?	N/A	N/A	Gutter Slope (%)	N/A
N/A	Gutter Lip Ht (in)	0.5	N/A	Gutter X Slope (%)	N/A
N/A	Painted X Walk1?	No	N/A	Painted X Walk2?	N/A
	X Walk 1 Direction	To S		X Walk 2 Direction	N/A
	X Walk 1 Width (in)	N/A		X Walk 2 Width (in)	N/A
	X Walk 1 Slope (%)	3.9		X Walk 2 Slope (%)	N/A
	X Walk 1 X Slope (%)	0.5		X Walk 2 X Slope (%)	N/A

N/A	Ramp inside XWalk1?	N/A	N/A	Ramp inside XWalk2?	N/A
	Road Slope (%)	0.5		Clear Space?	N/A
	Road X Slope (%)	3.9	N/A	Clear Space to XWalk (in)	N/A
N/A	Any Obstructions?	N/A	N/A	Storm Grate/Utility Hazard?	N/A
	Obstruction Type			Storm Grate/Utility Type	
		N/A			N/A
			Yes	Surface Condition? (G/P)	Good
			N/A	Curb Slope (%)	0.0

Remove & Replace Curb Ramp With Two New Directional Ramps or Equivalent.
