# Access Compliance Report

## Public Rights-of-Way

### (Curb Ramps)

Intersection ID: 2598	Main Street: DRISCOLL_CT	Cross Street: LAGRANDE_DR	Location: SE
ADA ID: E2822ED073D6	Ramp Type: BlendTrans1	Initial Pass/Fail: Fail	Overall Compliance: No
Severity Score: 8.75			
Codes/Mitigation Info/Possible Solution		Field Measurements/Component Compliance

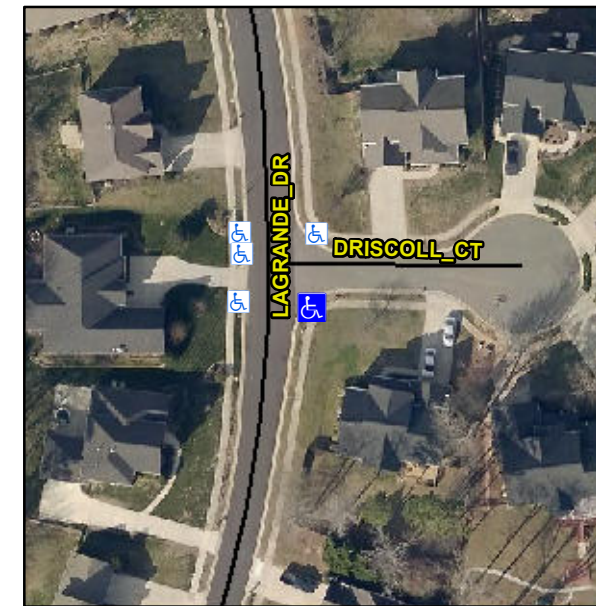
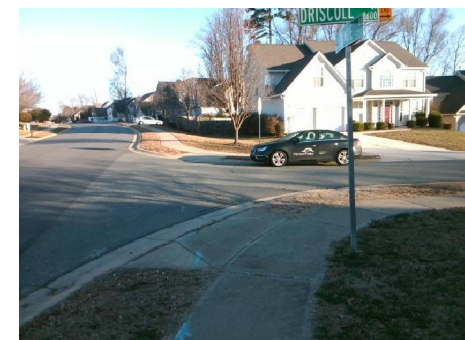
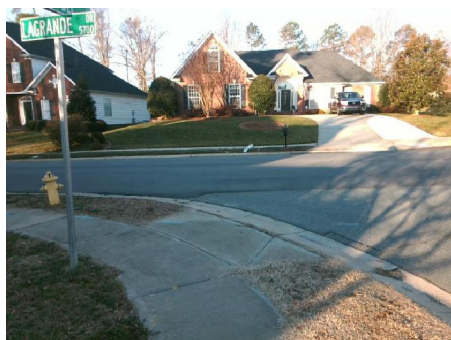
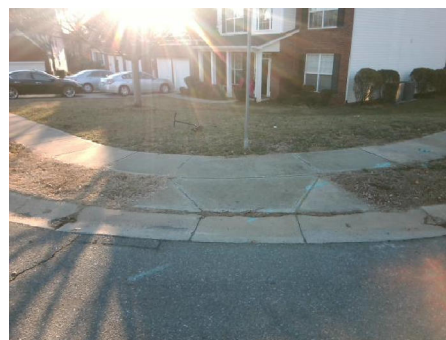
Compliance	Description	Data	Compliance	Description	Data
N/A	Ramp Length (in)	46.0	Yes	BlendTrans Slope (%)	2.8
No	Ramp Width (in)	45.0	Yes	BlendTrans XSlope (%)	2.0
N/A	Flare Type LT	N/A	N/A	Flare Type RT	N/A
N/A	Flare Slope LT (%)	N/A	N/A	Flare Slope RT (%)	N/A
N/A	Flare Traversable LT?	N/A	N/A	Flare Traversable RT?	N/A
N/A	Landing Length (in)	N/A	N/A	DWS Provided?	N/A
N/A	Landing Width (in)	N/A	N/A	DWS Contrast?	N/A
N/A	Landing Slope (%)	N/A	N/A	DWS Length (in)	N/A
N/A	Landing X Slope (%)	N/A	N/A	DWS Full Width?	N/A
N/A	Landing Curb? (Y/N)	N/A	N/A	DWS Offset (in)	N/A
N/A	Shared Landing?	N/A			
N/A	Gutter Ponding?	N/A	N/A	Gutter Slope (%)	N/A
N/A	Gutter Lip Ht (in)	N/A	N/A	Gutter X Slope (%)	N/A
N/A	Painted X Walk1?	No	N/A	Painted X Walk2?	No
	X Walk 1 Direction	To N		X Walk 2 Direction	To W
	X Walk 1 Width (in)	N/A		X Walk 2 Width (in)	N/A
	X Walk 1 Slope (%)	1.9		X Walk 2 Slope (%)	2.0
	X Walk 1 X Slope (%)	2.4		X Walk 2 X Slope (%)	3.1

N/A	Ramp inside XWalk1?	N/A	N/A	Ramp inside XWalk2?	N/A
	Road Slope (%)	1.0		Clear Space?	N/A
	Road X Slope (%)	6.7	N/A	Clear Space to XWalk (in)	N/A
N/A	Any Obstructions?	N/A	N/A	Storm Grate/Utility Hazard?	N/A
	Obstruction Type			Storm Grate/Utility Type	
		N/A			N/A
			Yes	Surface Condition? (G/P)	Good
			No	Curb Slope (%)	9.0

**Remove & Replace Curb Ramp With Two New Directional Ramps or Equivalent.**

**Not Found, R304.5.1**

Total Cost: \$ 3200.00
