# Access Compliance Report

## Public Rights-of-Way

### (Curb Ramps)

| Intersection ID: 47585 | Main Street: EVANTON_LOCH_RD | Cross Street: SEAMILL_RD | Location: SE |

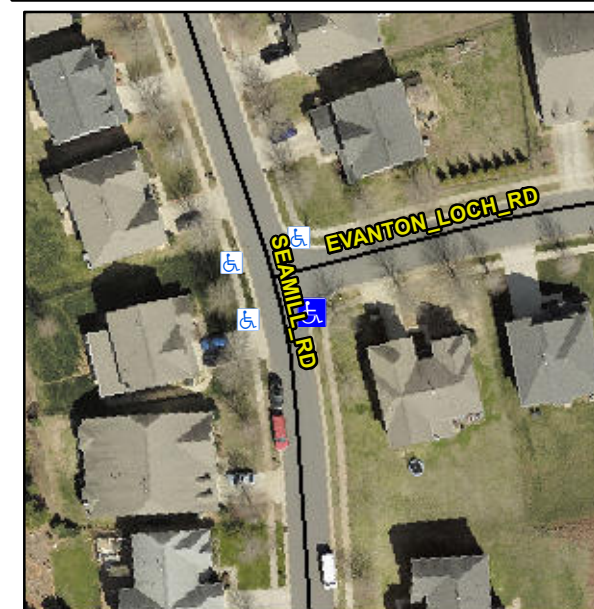
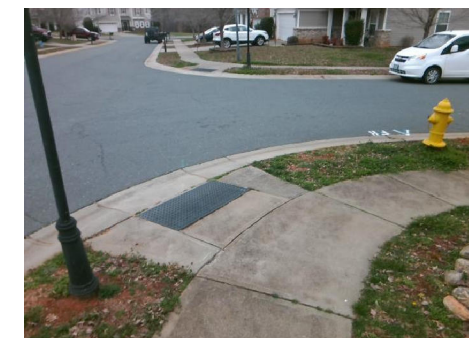
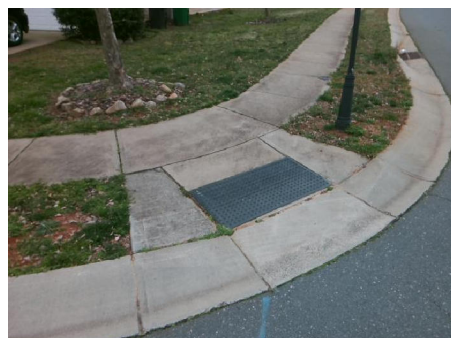
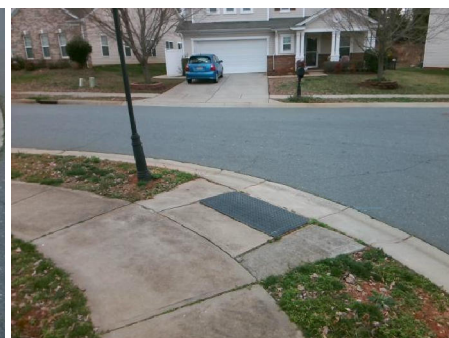
| ADA ID: E2876BD55FD3 | Ramp Type: PerpDiag | Initial Pass/Fail: Fail | Overall Compliance: No |
| Severity Score: 12.5 | | | |

| Compliance | Description | Data | Compliance | Description | Data |
|---|---|---|---|---|---|
| N/A | Ramp Length (in) | 48.0 | Yes | Ramp Slope (%) | 7.8 |
| Yes | Ramp Width (in) | 48.0 | No | Ramp XSlope (%) | 6.3 |

Possible Solutions:

**Remove & Replace Curb Ramp With Two New Directional Ramps or Equivalent.**

PROW/ADA:

**R304.5.3**
