Access Compliance Report

Public Rights-of-Way

(Curb Ramps)

Intersection ID: 42742	Main Street: MACANTHRA_DR	Cross Street: LEES_CROSSING_DR	Location:	N
ADA ID: E28C37B521FD	Ramp Type: PerpDiag	Initial Pass/Fail: Fail	Overall Compliance: No	Severity Score: 21.25
Codes/Mitigation Info/Possible Solution		Field Measurements/Component Compliance

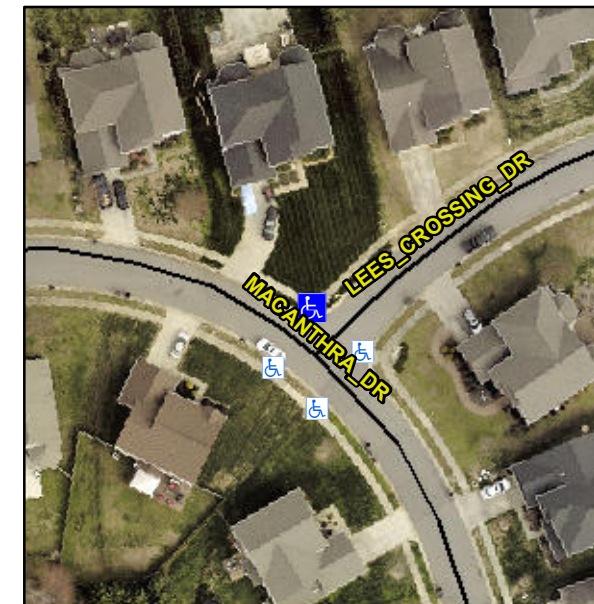
Not Found, R304.5.1, R304.5.3

Compliance	Description	Data	Compliance	Description	Data
N/A	Ramp Length (in)	48.0	Yes	Ramp Slope (%)	7.6
No	Ramp Width (in)	47.0	No	Ramp XSlope (%)	5.9
N/A	Flare Type LT	N/A	N/A	Flare Type RT	N/A
N/A	Flare Slope LT (%)	N/A	N/A	Flare Slope RT (%)	N/A
N/A	Flare Traversable LT?	N/A	N/A	Flare Traversable RT?	N/A
N/A	Landing Length (in)	N/A	N/A	DWS Provided?	N/A
N/A	Landing Width (in)	N/A	N/A	DWS Contrast?	N/A
N/A	Landing Slope (%)	N/A	N/A	DWS Length (in)	N/A
N/A	Landing X Slope (%)	N/A	N/A	DWS Full Width?	N/A
N/A	Landing Curb? (Y/N)	N/A	N/A	DWS Offset (in)	N/A
N/A	Shared Landing?	N/A			
N/A	Gutter Ponding?	N/A	N/A	Gutter Slope (%)	N/A
N/A	Gutter Lip Ht (in)	N/A	N/A	Gutter X Slope (%)	N/A
N/A	Painted X Walk1?	No	N/A	Painted X Walk2?	No
	X Walk 1 Direction	To W		X Walk 2 Direction	To E
N/A	X Walk 1 Width (in)	N/A	N/A	X Walk 2 Width (in)	N/A
	X Walk 1 Slope (%)	5.5		X Walk 2 Slope (%)	0.6
	X Walk 1 X Slope (%)	3.0		X Walk 2 X Slope (%)	6.7

N/A	Ramp inside XWalk1?	N/A	N/A	Ramp inside XWalk2?	N/A
	Road Slope (%)	5.6	N/A	Clear Space?	N/A
	Road X Slope (%)	4.6	N/A	Clear Space to XWalk (in)	N/A
N/A	Any Obstructions?	N/A	N/A	Storm Grate/Utility Hazard?	N/A
	Obstruction Type			Storm Grate/Utility Type	
		N/A			N/A
			Yes	Surface Condition? (G/P)	Good

Remove & Replace Curb Ramp With Two New Directional Ramps or Equivalent.
