# Access Compliance Report

## Public Rights-of-Way

### (Curb Ramps)

| Intersection ID: 14600 | Main Street: DILWORTH_RD | Cross Street: DILWORTH_RD_EAST | Location: NE |

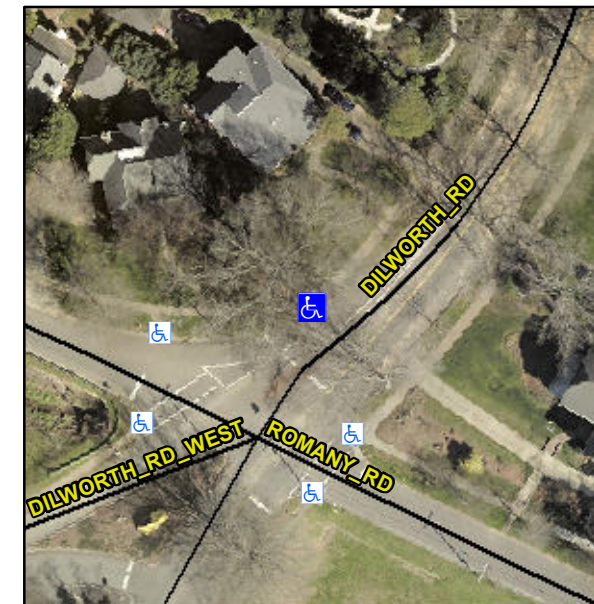
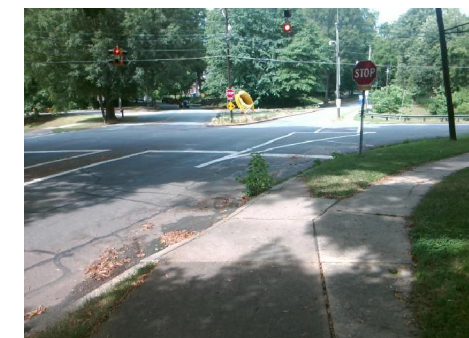
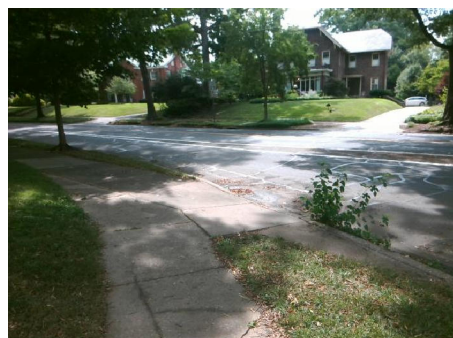
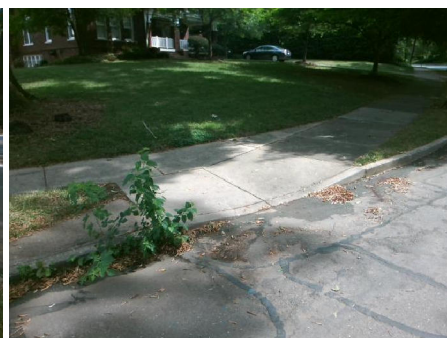
| ADA ID: E294B8DE3ACC | Ramp Type: Perp | Initial Pass/Fail: Fail | Overall Compliance: No |

**Not Found, R304.2.2, R304.5.3**

| Compliance | Description | Data | Compliance | Description | Data |
|---|---|---|---|---|---|
| N/A | Ramp Length (in) | 55.0 | No | Ramp Slope (%) | 11.4 |
| Yes | Ramp Width (in) | 48.0 | No | Ramp XSlope (%) | 4.4 |

**Remove & Replace Entire Ramp.**
