Access Compliance Report Public Rights-of-Way (Curb Ramps)

Intersection ID: 52912 Main Street: MARVIN RD Cross Street: CLEMS CREEK LN Location: SW **Overall Compliance: No Severity Score:** 1.25 ADA ID: E29C1E5D3E47 Ramp Type: Directional1 Initial Pass/Fail: Fail

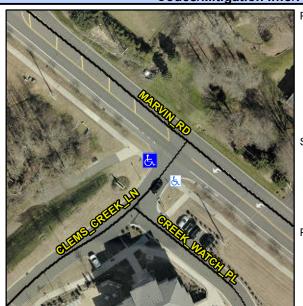
Compliance Description Data Compliance Description Data 130.0 N/A Grade Break? N/A Ramp Length (in) N/A 71.0 N/A Yes Ramp Width (in) Grade Break Slope (%) 0.0 N/A Yes Ramp Slope (%) 2.6 Grade Break XSlope (%) 0.0 No Ramp XSlope (%) 3.5 N/A Flare Type LT N/A N/A Flare Type RT N/A Flare Slope LT (%) N/A N/A Flare Slope RT (%) 0.0 Flare Traversable LT? N/A N/A Flare Traversable RT? N/A 0.0 N/A DWS Provided? Landing Length (in) N/A N/A **DWS Contrast?** Landing Width (in) 0.0 N/A Landing Slope (%) 0.0 N/A DWS Length (in) N/A 0.0 N/A DWS Full Width? Landing X Slope (%) N/A Landing Curb? (Y/N) N/A N/A DWS Offset LT (in) N/A Shared Landing? N/A N/A DWS Offset RT (in) N/A **Gutter Ponding?** 0.0 N/A Gutter Slope (%) N/A Gutter Lip Ht (in) 0.0 N/A Gutter X Slope (%) N/A Painted X Walk1? No Road Slope (%) 6.2 To SE X Walk 1 Direction Road X Slope (%) 0.6 N/A X Walk 1 Width (in) Clear Space? N/A X Walk 1 Slope (%) 6.2 N/A N/A Clear Space to XWalk (in) X Walk 1 X Slope (%) 0.6 N/A Storm Grate/Utility Hazard? N/A Ramp inside XWalk1? N/A Storm Grate/Utility Type Any Obstructions? N/A N/A **Obstruction Type** Surface Condition? (G/P) Yes Good N/A N/A Curb Slope (%) 6.5

CLEMS CREEK LN Street 1 Name Stop Condition-Street 1 StopSign N/A Street 2 Name Stop Condition-Street 2 N/A Possible Solutions: Remove & Replace Entire Ramp. Surveyor Notes: N/A PROW/ADA: R304.5.3
