Access Compliance Report

Public Rights-of-Way

(Curb Ramps)

Intersection ID: 24913	Main Street: HUGH_FOREST_RD	Cross Street: SYDNEY_DR	Location: NW
ADA ID: E2A7DC634B11	Ramp Type: Perp	Initial Pass/Fail: Fail	Overall Compliance: No
		Severity Score: 25

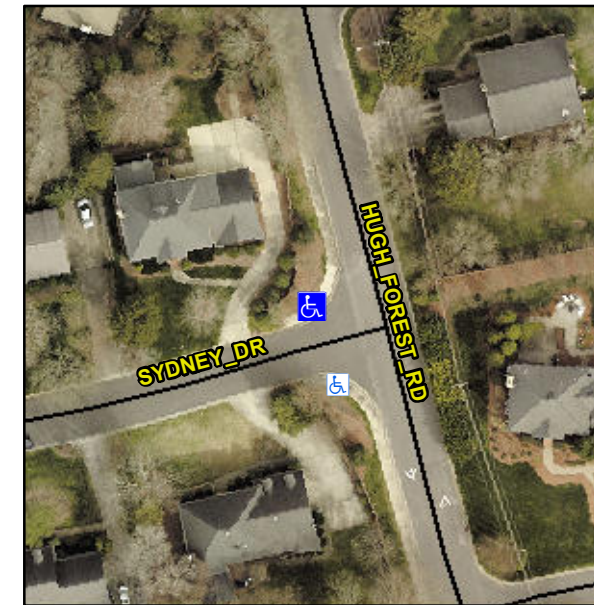
Not Found, R304.2.2

Compliance	Description	Data	Compliance	Description	Data
N/A	Ramp Length (in)	62.5	No	Ramp Slope (%)	15.0
Yes	Ramp Width (in)	48.0	Yes	Ramp XSlope (%)	1.1
N/A	Flare Type LT	N/A	N/A	Flare Type RT	N/A
N/A	Flare Slope LT (%)	N/A	N/A	Flare Slope RT (%)	N/A
N/A	Flare Traversable LT?	N/A	N/A	Flare Traversable RT?	N/A
N/A	Landing Length (in)	N/A	N/A	DWS Provided?	N/A
N/A	Landing Width (in)	N/A	N/A	DWS Contrast?	N/A
N/A	Landing Slope (%)	N/A	N/A	DWS Length (in)	N/A
N/A	Landing X Slope (%)	N/A	N/A	DWS Full Width?	N/A
N/A	Landing Curb? (Y/N)	N/A	N/A	DWS Offset (in)	N/A
N/A	Shared Landing?	N/A			
N/A	Gutter Ponding?	N/A	N/A	Gutter Slope (%)	N/A
N/A	Gutter Lip Ht (in)	N/A	N/A	Gutter X Slope (%)	N/A
N/A	Painted X Walk1?	No	N/A	Painted X Walk2?	N/A
	X Walk 1 Direction	To S		X Walk 2 Direction	N/A
N/A	X Walk 1 Width (in)	N/A	N/A	X Walk 2 Width (in)	N/A
	X Walk 1 Slope (%)	0.3		X Walk 2 Slope (%)	N/A
	X Walk 1 X Slope (%)	2.2		X Walk 2 X Slope (%)	N/A

Remove & Replace Entire Ramp.
