Access Compliance Report

Public Rights-of-Way

(Curb Ramps)

Intersection ID: 10021306	Main Street: BLAIREBETH_ST	Cross Street: N/A	Location: S
ADA ID: E2AABDCC79A0	Ramp Type: BlendTrans1	Initial Pass/Fail: Fail	Overall Compliance: No
		Severity Score: 1.25

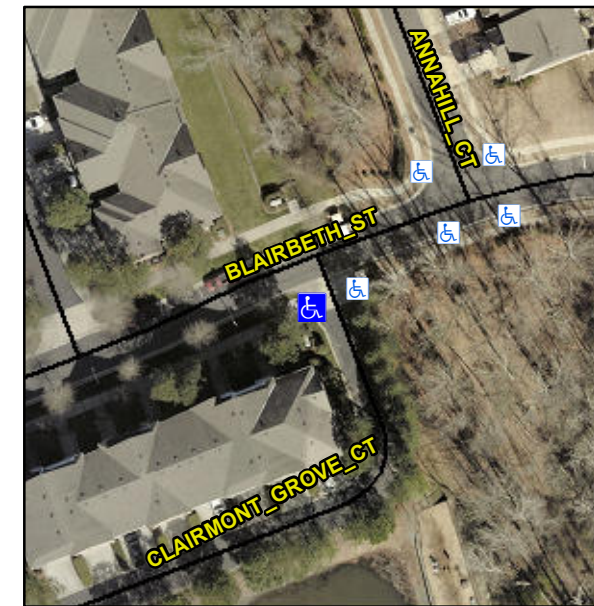
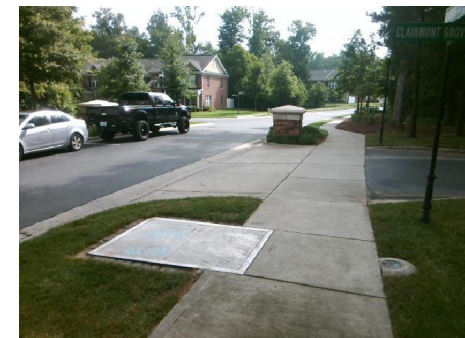
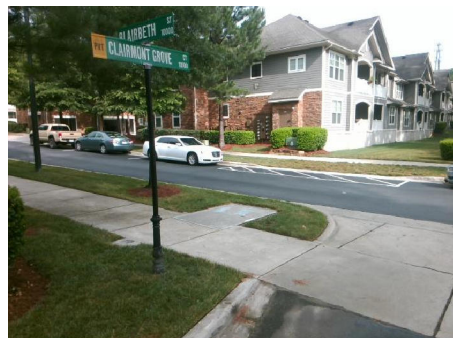
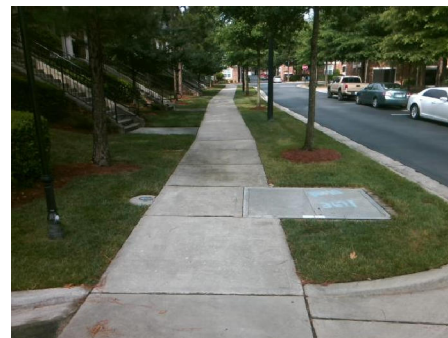
Compliance	Description	Data	Compliance	Description	Data
N/A	Ramp Length (in)	68.0	Yes	BlendTrans Slope (%)	1.7
Yes	Ramp Width (in)	72.0	No	BlendTrans XSlope (%)	3.1
N/A	Flare Type LT	N/A	N/A	Flare Type RT	N/A
N/A	Flare Slope LT (%)	N/A	N/A	Flare Slope RT (%)	N/A
N/A	Flare Traversable LT?	N/A	N/A	Flare Traversable RT?	N/A
N/A	Landing Length (in)	N/A	N/A	DWS Provided?	N/A
N/A	Landing Width (in)	N/A	N/A	DWS Contrast?	N/A
N/A	Landing Slope (%)	N/A	N/A	DWS Length (in)	N/A
N/A	Landing X Slope (%)	N/A	N/A	DWS Full Width?	N/A
N/A	Landing Curb? (Y/N)	N/A	N/A	DWS Offset (in)	N/A
N/A	Shared Landing?	N/A			
N/A	Gutter Ponding?	N/A	N/A	Gutter Slope (%)	N/A
N/A	Gutter Lip Ht (in)	N/A	N/A	Gutter X Slope (%)	N/A
N/A	Painted X Walk1?	No	N/A	Painted X Walk2?	N/A
	X Walk 1 Direction	To NE		X Walk 2 Direction	N/A
	X Walk 1 Width (in)	N/A		X Walk 2 Width (in)	N/A
	X Walk 1 Slope (%)	0.8		X Walk 2 Slope (%)	N/A
	X Walk 1 X Slope (%)	3.4		X Walk 2 X Slope (%)	N/A

N/A	Ramp inside XWalk1?	N/A	N/A	Ramp inside XWalk2?	N/A
	Road Slope (%)	3.4		Clear Space?	N/A
	Road X Slope (%)	0.8	N/A	Clear Space to XWalk (in)	N/A
N/A	Any Obstructions?	N/A	N/A	Storm Grate/Utility Hazard?	N/A
	Obstruction Type			Storm Grate/Utility Type	
		N/A			N/A
			Yes	Surface Condition? (G/P)	Good
			N/A	Curb Slope (%)	N/A

Remove & Replace Curb Ramp With Two New Directional Ramps or Equivalent.

R304.5.3

\$ 3200.00
