Access Compliance Report

Public Rights-of-Way

(Curb Ramps)

Intersection ID: 29709	Main Street: COLE_MILL_RD	Cross Street: LUTHERS_ROCK_CT	Location: E
ADA ID: E2AEC3C6DA64	Ramp Type: BlendTrans1	Initial Pass/Fail: Fail	Overall Compliance: No
		Severity Score: 8.75

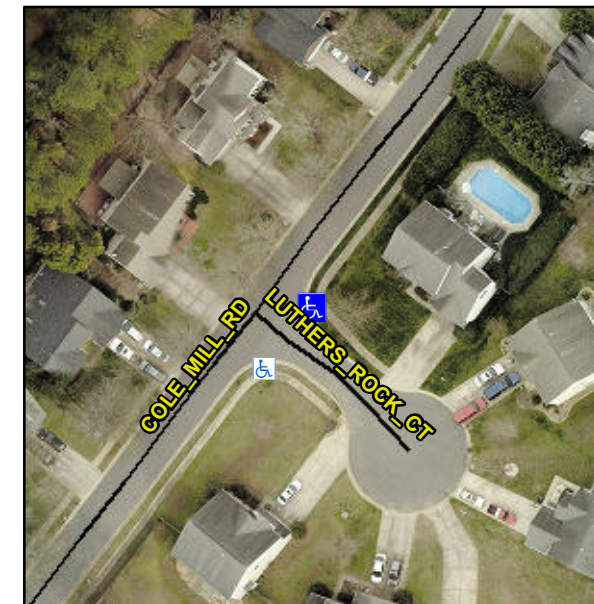
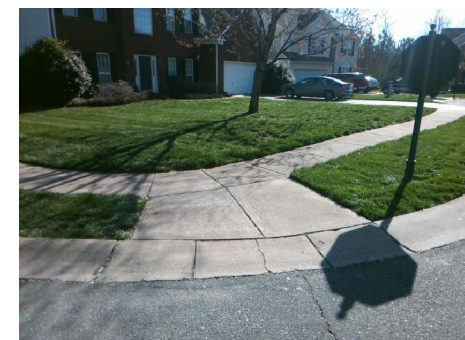
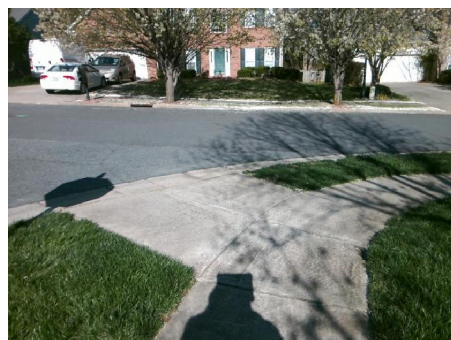
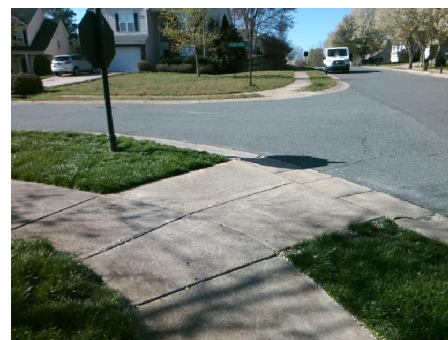
Compliance	Description	Data	Compliance	Description	Data
N/A	Ramp Length (in)	57.5	Yes	BlendTrans Slope (%)	1.1
No	Ramp Width (in)	45.0	Yes	BlendTrans XSlope (%)	1.6
N/A	Flare Type LT	N/A	N/A	Flare Type RT	N/A
N/A	Flare Slope LT (%)	N/A	N/A	Flare Slope RT (%)	N/A
N/A	Flare Traversable LT?	N/A	N/A	Flare Traversable RT?	N/A
N/A	Landing Length (in)	N/A	N/A	DWS Provided?	N/A
N/A	Landing Width (in)	N/A	N/A	DWS Contrast?	N/A
N/A	Landing Slope (%)	N/A	N/A	DWS Length (in)	N/A
N/A	Landing X Slope (%)	N/A	N/A	DWS Full Width?	N/A
N/A	Landing Curb? (Y/N)	N/A	N/A	DWS Offset (in)	N/A
N/A	Shared Landing?	N/A			
N/A	Gutter Ponding?	N/A	N/A	Gutter Slope (%)	N/A
N/A	Gutter Lip Ht (in)	N/A	N/A	Gutter X Slope (%)	N/A
N/A	Painted X Walk1?	No	N/A	Painted X Walk2?	No
	X Walk 1 Direction	To NW		X Walk 2 Direction	To SW
	X Walk 1 Width (in)	N/A		X Walk 2 Width (in)	N/A
	X Walk 1 Slope (%)	7.3		X Walk 2 Slope (%)	9.4
	X Walk 1 X Slope (%)	3.5		X Walk 2 X Slope (%)	1.9

N/A	Ramp inside XWalk1?	N/A	N/A	Ramp inside XWalk2?	N/A
	Road Slope (%)	3.7		Clear Space?	N/A
	Road X Slope (%)	5.8	N/A	Clear Space to XWalk (in)	N/A
N/A	Any Obstructions?	N/A	N/A	Storm Grate/Utility Hazard?	N/A
	Obstruction Type			Storm Grate/Utility Type	
		N/A			N/A
			Yes	Surface Condition? (G/P)	Good
			N/A	Curb Slope (%)	1.4

Remove & Replace Curb Ramp With Two New Directional Ramps or Equivalent.
