Access Compliance Report

Public Rights-of-Way

(Curb Ramps)

| Intersection ID: 43713 | Main Street: BIESTERFIELD_DR | Cross Street: HUNT_GLENN_CT | Location: NE |

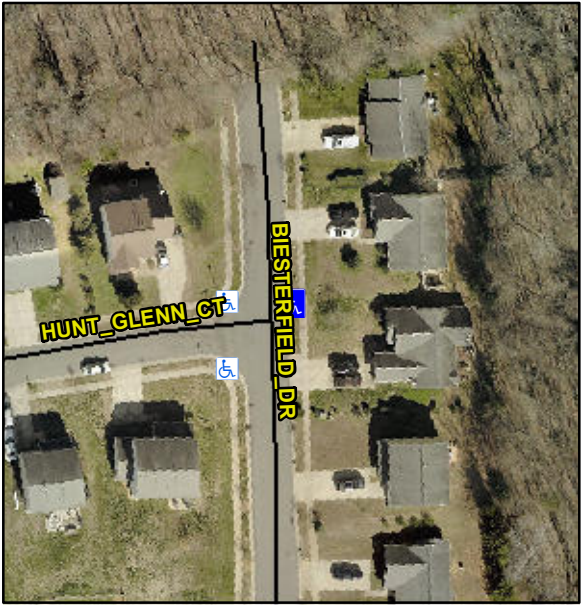
| Codes/Mitigation Info/Possible Solution | | | Field Measurements/Component Compliance | | |
|---|--|--|---|---|---|
| | | | No | Ramp Width (in) | 47.0 |
| <p>Surveyor Notes:</p> <p>N/A</p> <p>PROW/ADA:</p> <p>Not Found, R304.5.1, R304.5.3</p> | | | N/A | Flare Type RT | N/A |

| Codes/Mitigation Info/Possible Solution | | | Field Measurements/Component Compliance | | |
|---|--|--|---|---|---|
| | Remove & Replace Entire Ramp. | | N/A | Ramp Length (in) | 47.5 |
