Access Compliance Report

Public Rights-of-Way

(Curb Ramps)

Intersection ID: 51776	Main Street: MCVAY_ST	Cross Street: ORANGE_ST	Location: SE
ADA ID: E2B41B4822BC	Ramp Type: Directional1	Initial Pass/Fail: Fail	Overall Compliance: No
Severity Score: 1.25			
Codes/Mitigation Info/Possible Solution		Field Measurements/Component Compliance

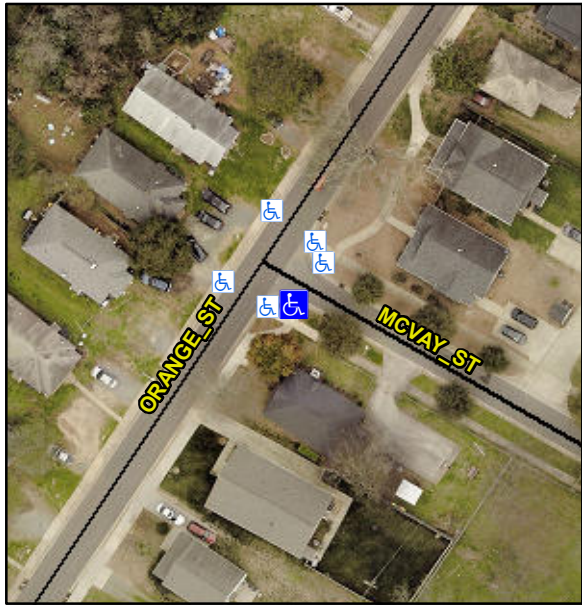
Possible Solutions:						
	Remove & Replace Entire Ramp.						
	Surveyor Notes: N/A	Compliance	Description	Data	Compliance	Description	Data
		N/A	Ramp Length (in)	74.0	N/A	Grade Break?	N/A
		Yes	Ramp Width (in)	60.0	N/A	Grade Break Slope (%)	0.0
		Yes	Ramp Slope (%)	5.5	N/A	Grade Break XSlope (%)	0.0
		No	Ramp XSlope (%)	3.0			
		N/A	Flare Type LT	N/A	N/A	Flare Type RT	N/A
		N/A	Flare Slope LT (%)	N/A	N/A	Flare Slope RT (%)	0.0
		N/A	Flare Traversable LT?	N/A	N/A	Flare Traversable RT?	N/A
PROW/ADA: R304.5.3	N/A	Landing Length (in)	0.0	N/A	DWS Provided?	N/A	
	N/A	Landing Width (in)	0.0	N/A	DWS Contrast?	N/A	
	N/A	Landing Slope (%)	0.0	N/A	DWS Length (in)	N/A	
	N/A	Landing X Slope (%)	0.0	N/A	DWS Full Width?	N/A	
	N/A	Landing Curb? (Y/N)	N/A	N/A	DWS Offset LT (in)	N/A	
	N/A	Shared Landing?	N/A	N/A	DWS Offset RT (in)	N/A	
	N/A	Gutter Ponding?	0.0	N/A	Gutter Slope (%)	N/A	
	N/A	Gutter Lip Ht (in)	0.0	N/A	Gutter X Slope (%)	N/A

N/A	Painted X Walk1?	No		Road Slope (%)	4.6	
		X Walk 1 Direction	To N		Road X Slope (%)	2.6	
		X Walk 1 Width (in)	N/A		Clear Space?	N/A	
		X Walk 1 Slope (%)	4.6	N/A	Clear Space to XWalk (in)	N/A	
		X Walk 1 X Slope (%)	2.6	N/A	Storm Grate/Utility Hazard?	N/A	
	N/A	Ramp inside XWalk1?	N/A		Storm Grate/Utility Type		
	N/A	Any Obstructions?	N/A			N/A	
	Obstruction Type		Yes	Surface Condition? (G/P)	Good		
		N/A	N/A	Curb Slope (%)	13.5		
Total Cost:	\$	1600.00
