# Access Compliance Report

## Public Rights-of-Way

### (Curb Ramps)

| Intersection ID: N/A | Main Street: QUEENS_RD_WEST | Cross Street: WELLESLEY_AV | Location: SE |

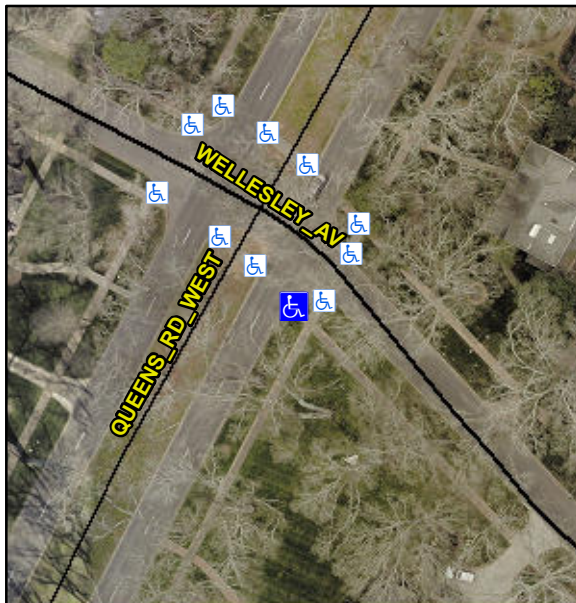
**R304.5.3, R304.2.1, R305.1.4, R305.2**

| Compliance | Description | Data | Compliance | Description | Data |
|---|---|---|---|---|---|
| Yes | Ramp Slope (%) | 3.8 | No | Grade Break XSlope (%) | 3.4 |
| No | Ramp XSlope (%) | 2.5 | | | |
| No | Landing Length (in) | 42.0 | Yes | DWS Provided? | Yes |
| Yes | Landing X Slope (%) | 1.1 | No | DWS Full Width? | No |
| N/A | Landing Curb? (Y/N) | No | No | DWS Offset LT (in) | 4.5 |

Possible Solutions:

**Remove & Replace Entire Ramp.**
