Access Compliance Report

Public Rights-of-Way

(Curb Ramps)

Intersection ID: 9807	Main Street: TINNIN_AV	Cross Street: DOUBLE_OAKS_RD	Location: SE
ADA ID: E2BEBED56EB9	Ramp Type: Perp	Initial Pass/Fail: Fail	Overall Compliance: No
Severity Score: 58.75			
Codes/Mitigation Info/Possible Solution		Field Measurements/Component Compliance

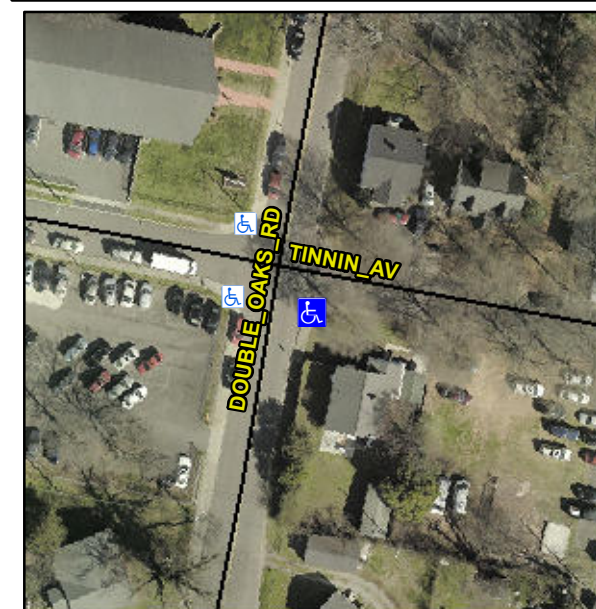
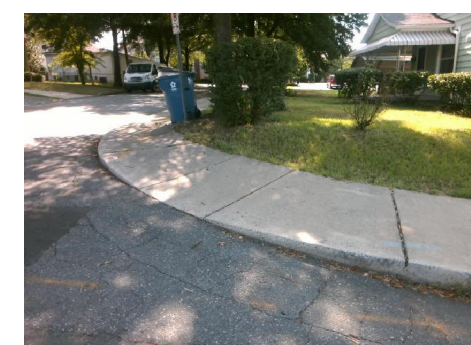
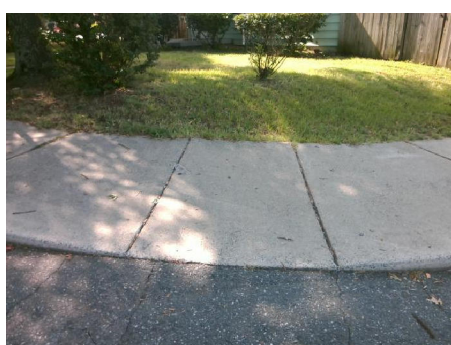
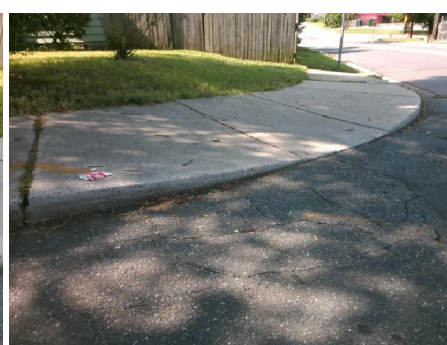
Compliance	Description	Data	Compliance	Description	Data
N/A	Ramp Length (in)	67.5	No	Ramp Slope (%)	12.8
No	Ramp Width (in)	38.5	No	Ramp XSlope (%)	7.3
N/A	Flare Type LT	N/A	N/A	Flare Type RT	N/A
N/A	Flare Slope LT (%)	N/A	N/A	Flare Slope RT (%)	N/A
N/A	Flare Traversable LT?	N/A	N/A	Flare Traversable RT?	N/A
N/A	Landing Length (in)	N/A	N/A	DWS Provided?	N/A
N/A	Landing Width (in)	N/A	N/A	DWS Contrast?	N/A
N/A	Landing Slope (%)	N/A	N/A	DWS Length (in)	N/A
N/A	Landing X Slope (%)	N/A	N/A	DWS Full Width?	N/A
N/A	Landing Curb? (Y/N)	N/A	N/A	DWS Offset (in)	N/A
N/A	Shared Landing?	N/A			
N/A	Gutter Ponding?	N/A	N/A	Gutter Slope (%)	N/A
N/A	Gutter Lip Ht (in)	N/A	N/A	Gutter X Slope (%)	N/A
N/A	Painted X Walk1?	No	N/A	Painted X Walk2?	N/A
	X Walk 1 Direction	To NW		X Walk 2 Direction	N/A
N/A	X Walk 1 Width (in)	N/A	N/A	X Walk 2 Width (in)	N/A
	X Walk 1 Slope (%)	1.6		X Walk 2 Slope (%)	N/A
	X Walk 1 X Slope (%)	5.8		X Walk 2 X Slope (%)	N/A

N/A	Ramp inside XWalk1?	N/A	N/A	Ramp inside XWalk2?	N/A
	Road Slope (%)	N/A	N/A	Clear Space?	N/A
	Road X Slope (%)	N/A	N/A	Clear Space to XWalk (in)	N/A
N/A	Any Obstructions?	N/A	N/A	Storm Grate/Utility Hazard?	N/A
	Obstruction Type			Storm Grate/Utility Type	
		N/A			N/A
			Yes	Surface Condition? (G/P)	Good

Possible Solutions:

Remove & Replace Entire Ramp.

R304.5.1, R304.2.2, R304.5.3
