# Access Compliance Report

## Public Rights-of-Way

### (Curb Ramps)

Intersection ID: 28914	Main Street: PINEVILLE-MATTHEWS_RD	Cross Street: SPRINGBANK_LN	Location: NE
ADA ID: E2C9366C505B	Ramp Type: ParaDiag	Initial Pass/Fail: Fail	Overall Compliance: No
Severity Score: 26.25			
Codes/Mitigation Info/Possible Solution		Field Measurements/Component Compliance

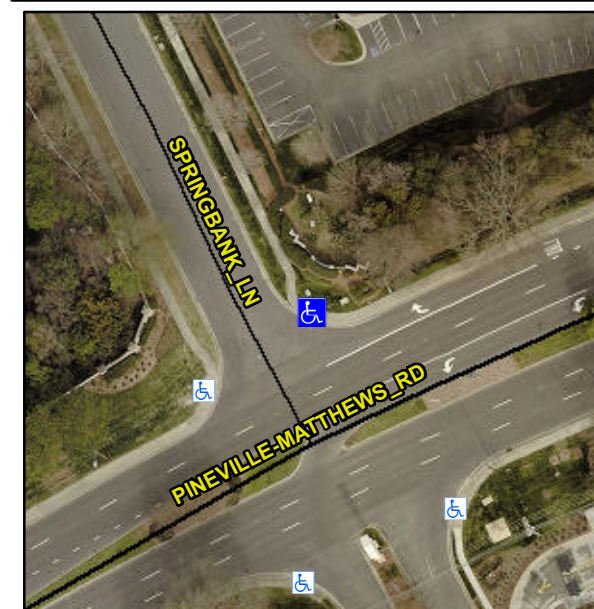
**DAMAGED DWS, LT RP < 5%**

**R304.5.3, R304.3.2**

Compliance	Description	Data	Compliance	Description	Data
N/A	Ramp Length LT (in)	64.0	N/A	Ramp Length RT (in)	64.0
Yes	Ramp Width LT (in)	60.0	Yes	Ramp Width RT (in)	60.0
Yes	Ramp Slope LT (%)	2.9	No	Ramp Slope RT (%)	19.7
No	Ramp XSlope LT (%)	4.2	Yes	Ramp XSlope RT (%)	1.9
N/A	Landing Length (in)	N/A	N/A	DWS Provided?	N/A
N/A	Landing Width (in)	N/A	N/A	DWS Contrast?	N/A
N/A	Landing Slope (%)	N/A	N/A	DWS Length (in)	N/A
N/A	Landing X Slope (%)	N/A	N/A	DWS Full Width?	N/A
N/A	Landing Curb? (Y/N)	N/A	N/A	DWS Offset (in)	N/A
N/A	Shared Landing?	N/A			
N/A	Gutter Ponding?	N/A	N/A	Gutter Slope (%)	N/A
N/A	Gutter Lip Ht (in)	N/A	N/A	Gutter X Slope (%)	N/A
N/A	Painted X Walk1?	No	N/A	Painted X Walk2?	No
	X Walk 1 Direction	To SW		X Walk 2 Direction	To S
N/A	X Walk 1 Width (in)	N/A	N/A	X Walk 2 Width (in)	N/A
	X Walk 1 Slope (%)	0.7		X Walk 2 Slope (%)	3.9
	X Walk 1 X Slope (%)	8.7		X Walk 2 X Slope (%)	3.6
N/A	Ramp inside XWalk1?	N/A	N/A	Ramp inside XWalk2?	N/A

Road Slope (%)	6.7	N/A	Clear Space?	N/A
	Road X Slope (%)	4.5	N/A	Clear Space to XWalk (in)	N/A
N/A	Any Obstructions?	N/A	N/A	Storm Grate/Utility Hazard?	N/A
	Obstruction Type			Storm Grate/Utility Type	
		N/A			N/A
			Yes	Surface Condition? (G/P)	Good
			N/A	Curb Slope (%)	6.8

**Remove & Replace Curb Ramp With Two New Directional Ramps or Equivalent.**

Total Cost: \$ 3200.00
