# Access Compliance Report

## Public Rights-of-Way

### (Curb Ramps)

Intersection ID: 15040	Main Street: TELEVISION_PL	Cross Street: WASHBURN_AV	Location: SE
ADA ID: E2C983E8348B	Ramp Type: Perp	Initial Pass/Fail: Fail	Overall Compliance: No
		Severity Score: 10

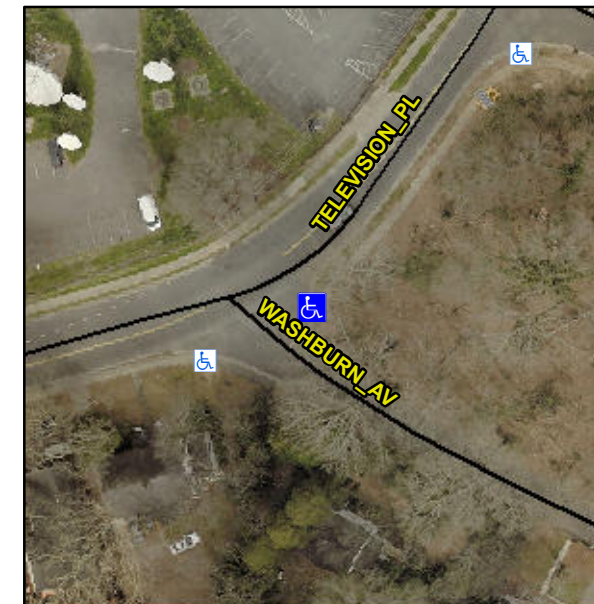
**Not Found, R304.5.1, R304.5.3**

Compliance	Description	Data	Compliance	Description	Data
N/A	Ramp Length (in)	58.0	Yes	Ramp Slope (%)	5.1
No	Ramp Width (in)	43.0	No	Ramp XSlope (%)	4.5
N/A	Flare Type LT	N/A	N/A	Flare Type RT	N/A
N/A	Flare Slope LT (%)	N/A	N/A	Flare Slope RT (%)	N/A
N/A	Flare Traversable LT?	N/A	N/A	Flare Traversable RT?	N/A
N/A	Landing Length (in)	N/A	N/A	DWS Provided?	N/A
N/A	Landing Width (in)	N/A	N/A	DWS Contrast?	N/A
N/A	Landing Slope (%)	N/A	N/A	DWS Length (in)	N/A
N/A	Landing X Slope (%)	N/A	N/A	DWS Full Width?	N/A
N/A	Landing Curb? (Y/N)	N/A	N/A	DWS Offset (in)	N/A
N/A	Shared Landing?	N/A			
N/A	Gutter Ponding?	N/A	N/A	Gutter Slope (%)	N/A
N/A	Gutter Lip Ht (in)	N/A	N/A	Gutter X Slope (%)	N/A
N/A	Painted X Walk1?	No	N/A	Painted X Walk2?	N/A
	X Walk 1 Direction	To W		X Walk 2 Direction	N/A
N/A	X Walk 1 Width (in)	N/A	N/A	X Walk 2 Width (in)	N/A
	X Walk 1 Slope (%)	5.7		X Walk 2 Slope (%)	N/A
	X Walk 1 X Slope (%)	1.3		X Walk 2 X Slope (%)	N/A

N/A	Ramp inside XWalk1?	N/A	N/A	Ramp inside XWalk2?	N/A
	Road Slope (%)	N/A	N/A	Clear Space?	N/A
	Road X Slope (%)	N/A	N/A	Clear Space to XWalk (in)	N/A
N/A	Any Obstructions?	N/A	N/A	Storm Grate/Utility Hazard?	N/A
	Obstruction Type			Storm Grate/Utility Type	
		N/A			N/A
		Yes		Surface Condition? (G/P)	Good

**Remove & Replace Entire Ramp.**
