Access Compliance Report

Public Rights-of-Way

(Curb Ramps)

Intersection ID: 32102	Main Street: BLUE_HERON_DR	Cross Street: CASTLE_PINE_CT	Location: SW
ADA ID: E2CCE2AF5F83	Ramp Type: Directional	Initial Pass/Fail: Fail	Overall Compliance: No
		Severity Score: 1.25

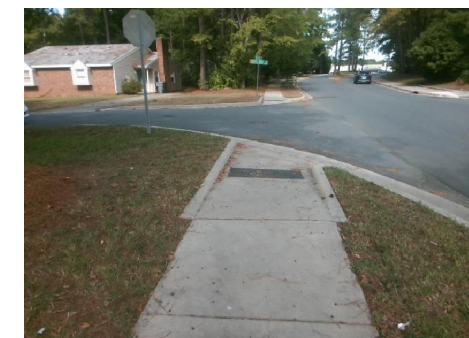
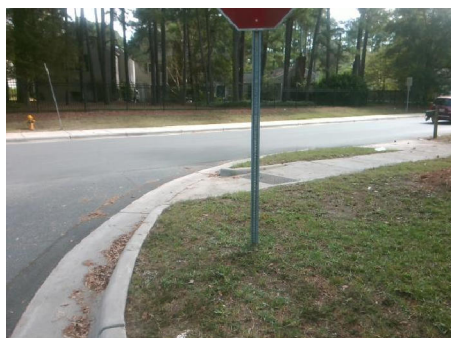
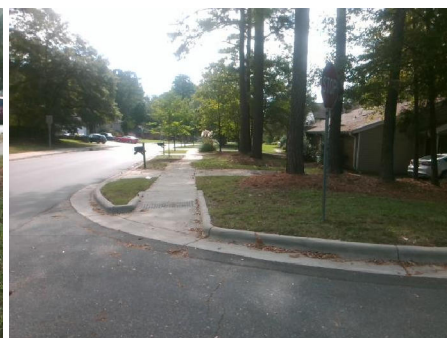
Compliance	Description	Data	Compliance	Description	Data
N/A	Ramp Length (in)	92.0	N/A	Grade Break?	N/A
Yes	Ramp Width (in)	58.0	N/A	Grade Break Slope (%)	0.0
Yes	Ramp Slope (%)	2.4	N/A	Grade Break XSlope (%)	0.0
No	Ramp XSlope (%)	3.6			
N/A	Flare Type LT	N/A	N/A	Flare Type RT	N/A
N/A	Flare Slope LT (%)	N/A	N/A	Flare Slope RT (%)	0.0
N/A	Flare Traversable LT?	N/A	N/A	Flare Traversable RT?	N/A
N/A	Landing Length (in)	0.0	N/A	DWS Provided?	N/A
N/A	Landing Width (in)	0.0	N/A	DWS Contrast?	N/A
N/A	Landing Slope (%)	0.0	N/A	DWS Length (in)	N/A
N/A	Landing X Slope (%)	0.0	N/A	DWS Full Width?	N/A
N/A	Landing Curb? (Y/N)	N/A	N/A	DWS Offset LT (in)	N/A
N/A	Shared Landing?	N/A	N/A	DWS Offset RT (in)	N/A
N/A	Gutter Ponding?	0.0	N/A	Gutter Slope (%)	N/A
N/A	Gutter Lip Ht (in)	0.0	N/A	Gutter X Slope (%)	N/A
N/A	Painted X Walk1?	No		Road Slope (%)	1.9
	X Walk 1 Direction	To NW		Road X Slope (%)	1.1
	X Walk 1 Width (in)	N/A		Clear Space?	N/A

X Walk 1 Slope (%)	1.9	N/A	Clear Space to XWalk (in)	N/A
	X Walk 1 X Slope (%)	1.1	N/A	Storm Grate/Utility Hazard?	N/A
N/A	Ramp inside XWalk1?	N/A		Storm Grate/Utility Type	
N/A	Any Obstructions?	N/A			N/A
	Obstruction Type		Yes	Surface Condition? (G/P)	Good
			N/A	Curb Slope (%)	7.6

Possible Solutions:

Remove & Replace Entire Ramp.

R304.5.3
