## **Access Compliance Report Public Rights-of-Way** (Curb Ramps)

Intersection ID: 29604 Main Street: CAMDEN CREEK LN **Cross Street: SANDY PORTER RD** Location: ADA ID: E2D3B95D4E3F Ramp Type: PerpDiag Initial Pass/Fail: Fail **Overall Compliance: No** Severity Score: 31.25

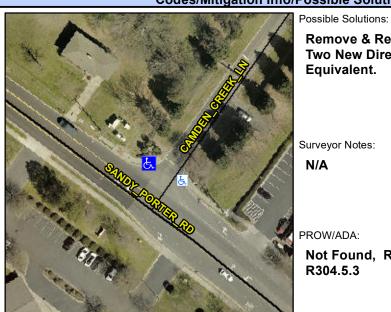
Not Found, R304.5.1, R304.2.2, R304.5.3

Field Measurements/Component Compilance						
	Compl	iance Description	Data Compliance Description			Data
	N/A	Ramp Length (in)	71.0	No	Ramp Slope (%)	9.2
	No	Ramp Width (in)	34.5	No	Ramp XSlope (%)	2.1
	N/A	Flare Type LT	N/A	N/A	Flare Type RT	N/A
	N/A	Flare Slope LT (%)	N/A	N/A	Flare Slope RT (%)	N/A
	N/A	Flare Traversable LT?	N/A	N/A	Flare Traversable RT?	N/A
	N/A	Landing Length (in)	N/A	N/A	DWS Provided?	N/A
	N/A	Landing Width (in)	N/A	N/A	DWS Contrast?	N/A
	N/A	Landing Slope (%)	N/A	N/A	DWS Length (in)	N/A
	N/A	Landing X Slope (%)	N/A	N/A	DWS Full Width?	N/A
	N/A	Landing Curb? (Y/N)	N/A	N/A	DWS Offset (in)	N/A
	N/A	Shared Landing?	N/A			
	N/A	Gutter Ponding?	N/A	N/A	Gutter Slope (%)	N/A
	N/A	Gutter Lip Ht (in)	N/A	N/A	Gutter X Slope (%)	N/A
	N/A	Painted X Walk1?	No	N/A	Painted X Walk2?	No
		X Walk 1 Direction	To SW		X Walk 2 Direction	To SE
	N/A	X Walk 1 Width (in)	N/A	N/A	X Walk 2 Width (in)	N/A
		X Walk 1 Slope (%)	4.1		X Walk 2 Slope (%)	0.4

X Walk 1 X Slope (%)	2.7		X Walk 2 X Slope (%)	2.3
	N/A	Ramp inside XWalk1?	N/A	N/A	Ramp inside XWalk2?	N/A
		Road Slope (%)	7.4	N/A	Clear Space?	N/A
		Road X Slope (%)	0.9	N/A	Clear Space to XWalk (in)	N/A
	N/A	Any Obstructions?	N/A	N/A	Storm Grate/Utility Hazard?	N/A
		Obstruction Type			Storm Grate/Utility Type	
			N/A			N/A
				Yes	Surface Condition? (G/P)	Good
		WARRANT LANGUAGE

Street 1 Name Stop Condition-Street 2 Street 2 Name Stop Condition-Street 1 **SANDY PORTER RD** None **CAMDEN CREEK LN** StopSign Remove & Replace Curb Ramp With Two New Directional Ramps or Equivalent.
