Access Compliance Report

Public Rights-of-Way

(Curb Ramps)

Intersection ID: 10772	Main Street: E_36TH_ST	Cross Street: THE_PLAZA	Location: SE
ADA ID: E2D46F18CABA	Ramp Type: Perp	Initial Pass/Fail: Pass	Overall Compliance: No
Severity Score: 22.5			
Codes/Mitigation Info/Possible Solution		Field Measurements/Component Compliance

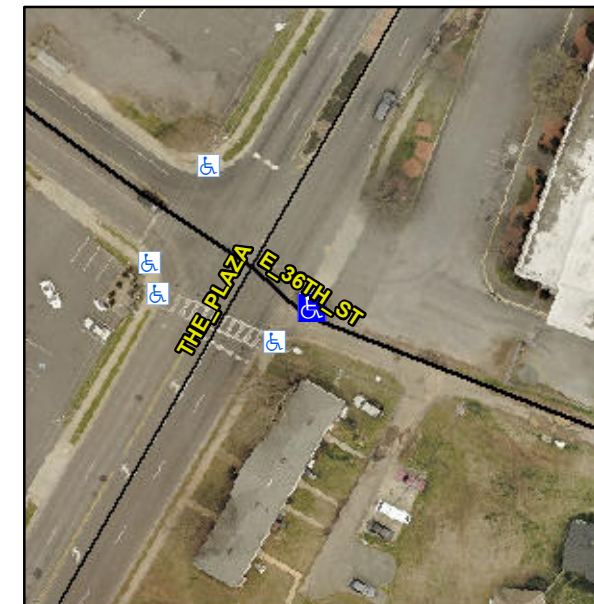
**Not Found, R304.2.2-Perp, R304.3.2-
Para, R305, R302.7, R302.7.2,
R304.5.4**

Possible Solutions:

**Remove & Replace Entire Ramp.
Remove & Replace Gutter.**
