Access Compliance Report Public Rights-of-Way (Curb Ramps)

Intersection ID: 15858 Main Street: E_W_T_HARRIS_BV Cross Street: SNOW_LN Location: SE

ADA ID: E2DE9039AE0C Ramp Type: Directional1 Initial Pass/Fail: Fail Overall Compliance: No Severity Score: 1.25

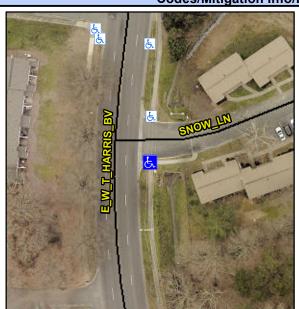
o/Possible Solution	Field Measurements/Component Compliance					
Possible Solutions:	Compl	iance Description	Data	Complia	nce Description	Data
Remove & Replace Entire Ramp.	N/A	Ramp Length (in)	45.0	N/A	Grade Break?	N/A
	Yes	Ramp Width (in)	60.0	N/A	Grade Break Slope (%)	0.0
	Yes	Ramp Slope (%)	3.0	N/A	Grade Break XSlope (%)	0.0
	No	Ramp XSlope (%)	3.9			
	N/A	Flare Type LT	N/A	N/A	Flare Type RT	N/A
V	N/A	Flare Slope LT (%)	N/A	N/A	Flare Slope RT (%)	0.0
Surveyor Notes:	N/A	Flare Traversable LT?	N/A	N/A	Flare Traversable RT?	N/A
N/A	N/A	Landing Length (in)	0.0	N/A	DWS Provided?	N/A
	N/A	Landing Width (in)	0.0	N/A	DWS Contrast?	N/A
	N/A	Landing Slope (%)	0.0	N/A	DWS Length (in)	N/A
	N/A	Landing X Slope (%)	0.0	N/A	DWS Full Width?	N/A
PROW/ADA:	N/A	Landing Curb? (Y/N)	N/A	N/A	DWS Offset LT (in)	N/A
R304.5.3	N/A	Shared Landing?	N/A	N/A	DWS Offset RT (in)	N/A
	N/A	Gutter Ponding?	0.0	N/A	Gutter Slope (%)	N/A

N/A	Gutter Lip Ht (in)	0.0	N/A	Gutter X Slope (%)	N/A
	N/A	Painted X Walk1?	No		Road Slope (%)	2.1
		X Walk 1 Direction	To N		Road X Slope (%)	1.7
		X Walk 1 Width (in)	N/A		Clear Space?	N/A
		X Walk 1 Slope (%)	2.1	N/A	Clear Space to XWalk (in)	N/A
		X Walk 1 X Slope (%)	1.7	N/A	Storm Grate/Utility Hazard?	N/A
	N/A	Ramp inside XWalk1?	N/A		Storm Grate/Utility Type	
	N/A	Any Obstructions?	N/A			N/A
Total Cost: \$ 1600.00		Obstruction Type		Yes	Surface Condition? (G/P)	Good
			N/A	N/A	Curb Slope (%)	17.7
