Access Compliance Report

Public Rights-of-Way (Curb Ramps)

Intersection ID: 48460	Main Street: TARPWAY_RD	Cross Street: PANGLEMONT_DR	Location: NW
ADA ID: E2ECF023087C	Ramp Type: Perp	Initial Pass/Fail: Fail	Overall Compliance: No
Severity Score: 35			
Codes/Mitigation Info/Possible Solution		Field Measurements/Component Compliance

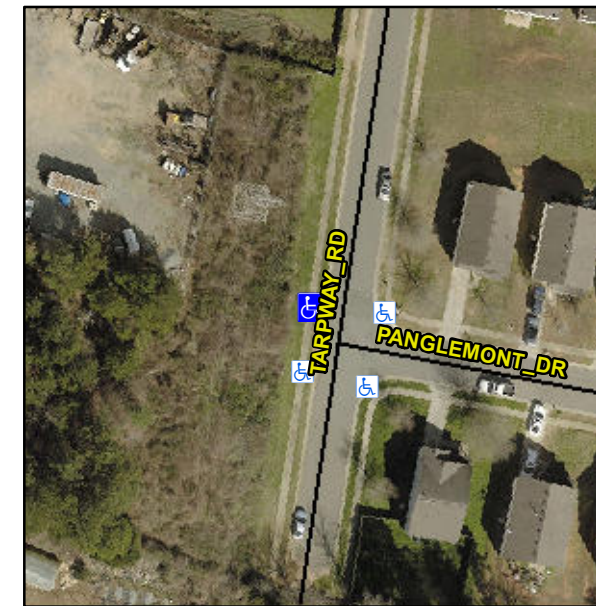
Not Found, R304.5.1, R304.2.2, R304.5.3

Compliance	Description	Data	Compliance	Description	Data
N/A	Ramp Length (in)	48.0	No	Ramp Slope (%)	18.6
No	Ramp Width (in)	47.5	No	Ramp XSlope (%)	3.7
N/A	Flare Type LT	N/A	N/A	Flare Type RT	N/A
N/A	Flare Slope LT (%)	N/A	N/A	Flare Slope RT (%)	N/A
N/A	Flare Traversable LT?	N/A	N/A	Flare Traversable RT?	N/A
N/A	Landing Length (in)	N/A	N/A	DWS Provided?	N/A
N/A	Landing Width (in)	N/A	N/A	DWS Contrast?	N/A
N/A	Landing Slope (%)	N/A	N/A	DWS Length (in)	N/A
N/A	Landing X Slope (%)	N/A	N/A	DWS Full Width?	N/A
N/A	Landing Curb? (Y/N)	N/A	N/A	DWS Offset (in)	N/A
N/A	Shared Landing?	N/A			
N/A	Gutter Ponding?	N/A	N/A	Gutter Slope (%)	N/A
N/A	Gutter Lip Ht (in)	N/A	N/A	Gutter X Slope (%)	N/A
N/A	Painted X Walk1?	No	N/A	Painted X Walk2?	N/A
	X Walk 1 Direction	To E		X Walk 2 Direction	N/A
N/A	X Walk 1 Width (in)	N/A	N/A	X Walk 2 Width (in)	N/A
	X Walk 1 Slope (%)	1.2		X Walk 2 Slope (%)	N/A
	X Walk 1 X Slope (%)	2.9		X Walk 2 X Slope (%)	N/A

Remove & Replace Entire Ramp.
