# Access Compliance Report

## Public Rights-of-Way

| Intersection ID: 30497 | Main Street: STONES_LANDING_ST | Cross Street: WALKING_STICK_DR | Location: SW |
| ADA ID: E2ED0C9D4053 | Ramp Type: BlendTrans1 | Initial Pass/Fail: Fail | Overall Compliance: No |

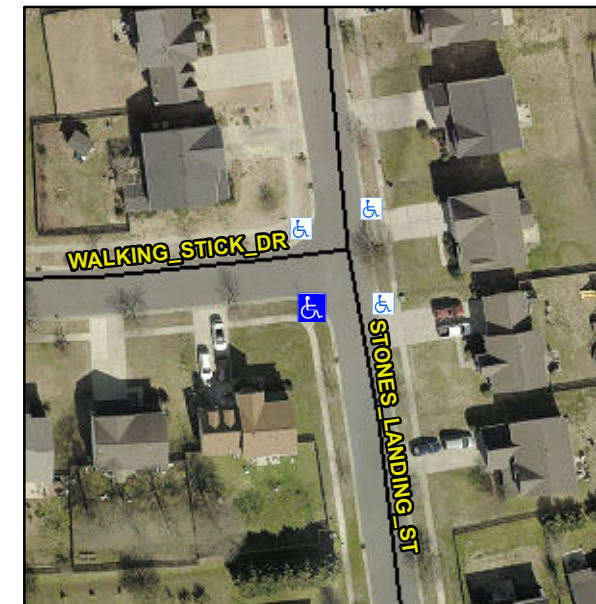
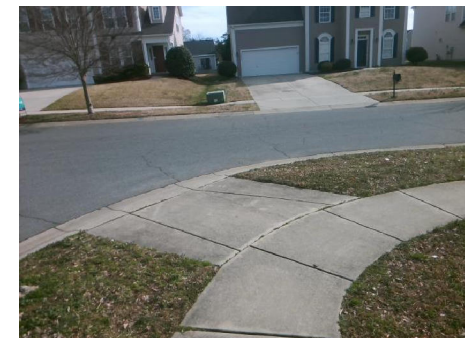
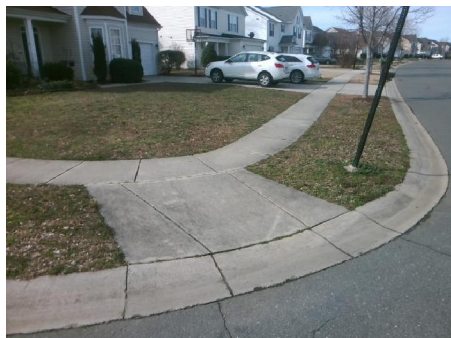
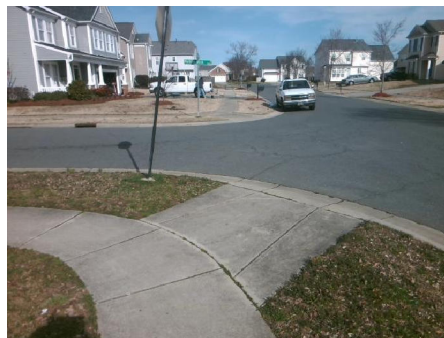
| | | Severity Score: 10 | |

**R304.5.1, R304.5.3**

| Compliance | Description | Data | Compliance | Description | Data |
|---|---|---|---|---|---|
| No | Ramp Width (in) | 45.5 | No | BlendTrans XSlope (%) | 3.4 |

**Remove & Replace Curb Ramp With Two New Directional Ramps or Equivalent.**

Total Cost: \$ 3200.00
