# Access Compliance Report

## Public Rights-of-Way

### (Curb Ramps)

| Intersection ID: 29420 | Main Street: BRADSTREET_COMMONS_WY | Cross Street: SALINGER_WY | Location: NW |

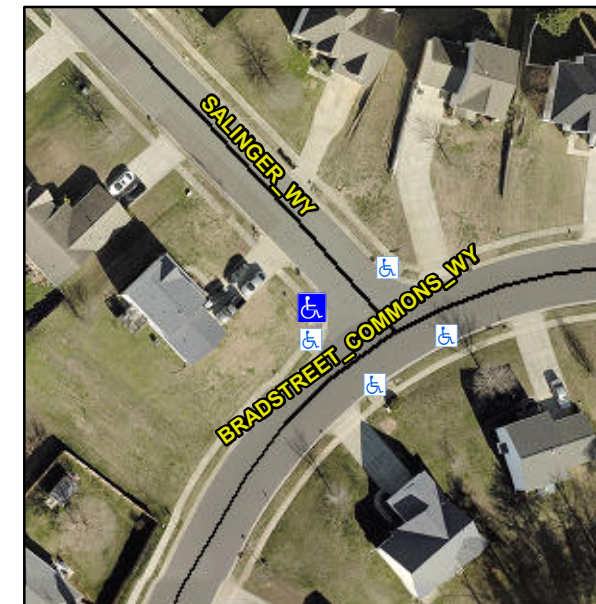
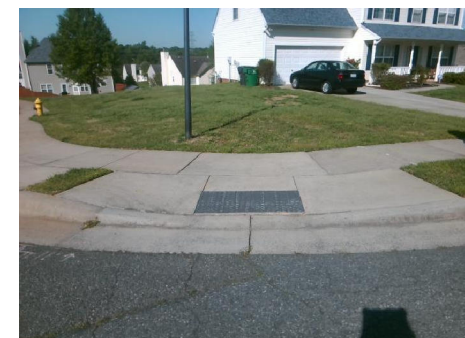
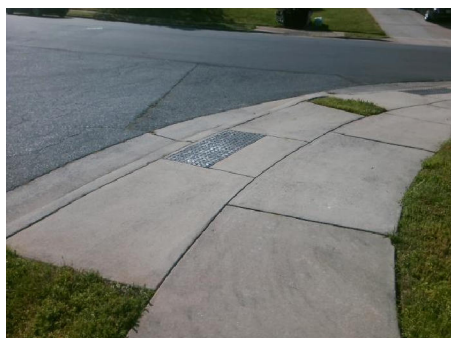
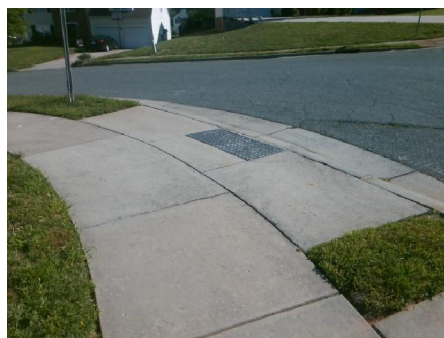
| ADA ID: E2F905079775 | Ramp Type: BlendTrans1 | Initial Pass/Fail: Fail | Overall Compliance: No |

| Severity Score: 8.75 | | | |

**Not Found, R304.5.1**

| Compliance | Description | Data | Compliance | Description | Data |
|---|---|---|---|---|---|
| N/A | Ramp Length (in) | 47.5 | Yes | BlendTrans Slope (%) | 3.7 |
| No | Ramp Width (in) | 46.0 | Yes | BlendTrans XSlope (%) | 1.9 |
| | | | No | Curb Slope (%) | 17.9 |

**Remove & Replace Curb Ramp With Two New Directional Ramps or Equivalent.**

Total Cost: \$ 3200.00
