## **Access Compliance Report Public Rights-of-Way** (Curb Ramps)

Intersection ID: 17457 Main Street: S WENDOVER RD **Cross Street: VERNON DR** Location: SE **Overall Compliance: No Severity Score:** 12.5 **ADA ID: E2FCA37118C7** Ramp Type: Perp Initial Pass/Fail: Fail

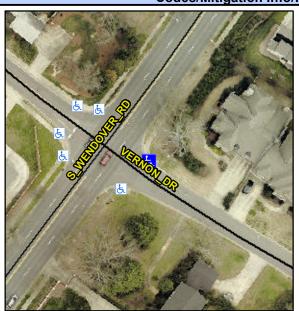
**VERNON DR** Street 1 Name Stop Condition-Street 2 StopSign N/A Street 2 Name Stop Condition-Street 1 N/A Possible Solutions: Remove & Replace Entire Ramp. Surveyor Notes: N/A PROW/ADA: R304.2.2
