Access Compliance Report

Public Rights-of-Way

(Curb Ramps)

Intersection ID: N/A	Main Street: SPEER_BV	Cross Street: NATIONAL_AV	Location: NE
ADA ID: E301A22AD642	Ramp Type: BlendTrans1	Initial Pass/Fail: Pass	Overall Compliance: No
Severity Score: 5			
Codes/Mitigation Info/Possible Solution		Field Measurements/Component Compliance

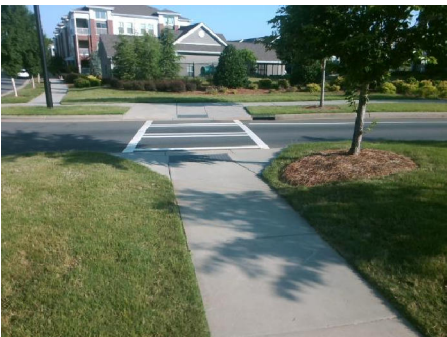
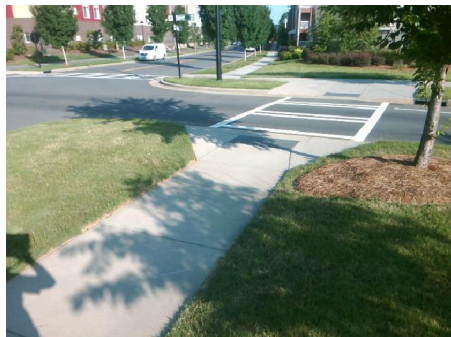
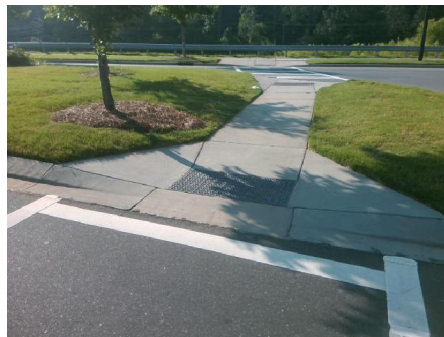
LOCATED ON MEDIAN

Compliance	Description	Data	Compliance	Description	Data
N/A	Ramp Length (in)	154.0	Yes	BlendTrans Slope (%)	2.5
Yes	Ramp Width (in)	48.0	Yes	BlendTrans XSlope (%)	1.4
N/A	Flare Type LT	Sloped	N/A	Flare Type RT	Sloped
N/A	Flare Slope LT (%)	10.2	N/A	Flare Slope RT (%)	7.2
N/A	Flare Traversable LT?	No	N/A	Flare Traversable RT?	No
Yes	Landing Length (in)	52.0	Yes	DWS Provided?	Yes
Yes	Landing Width (in)	54.0	Yes	DWS Contrast?	Yes
Yes	Landing Slope (%)	1.0	Yes	DWS Length (in)	24.0
Yes	Landing X Slope (%)	1.5	Yes	DWS Full Width?	Yes
N/A	Landing Curb? (Y/N)	No	Yes	DWS Offset (in)	0.0
N/A	Shared Landing?	Yes			
Yes	Gutter Ponding?	No	No	Gutter Slope (%)	8.3
Yes	Gutter Lip Ht (in)	0.0	Yes	Gutter X Slope (%)	2.1
N/A	Painted X Walk1?	Yes	N/A	Painted X Walk2?	N/A
	X Walk 1 Direction	To NW		X Walk 2 Direction	N/A
	X Walk 1 Width (in)	112.0		X Walk 2 Width (in)	N/A
	X Walk 1 Slope (%)	1.4		X Walk 2 Slope (%)	N/A
	X Walk 1 X Slope (%)	2.3		X Walk 2 X Slope (%)	N/A

Yes	Ramp inside XWalk1?	Yes	N/A	Ramp inside XWalk2?	N/A
	Road Slope (%)	2.3		Clear Space?	Yes
	Road X Slope (%)	1.4	N/A	Clear Space to XWalk (in)	N/A
Yes	Any Obstructions?	No	Yes	Storm Grate/Utility Hazard?	No
	Obstruction Type			Storm Grate/Utility Type	
		N/A			N/A
			Yes	Surface Condition? (G/P)	Good
			Yes	Curb Slope (%)	4.1

Possible Solutions:

Remove & Replace Gutter.

R304.5.4
