# Access Compliance Report

## Public Rights-of-Way

### (Curb Ramps)

Intersection ID: 26725	Main Street: BEACON_FOREST_DR	Cross Street: MANOR_HOUSE_DR	Location: SW
ADA ID: E309677B665F	Ramp Type: BlendTrans1	Initial Pass/Fail: Fail	Overall Compliance: No
Severity Score: 10			
Codes/Mitigation Info/Possible Solution		Field Measurements/Component Compliance

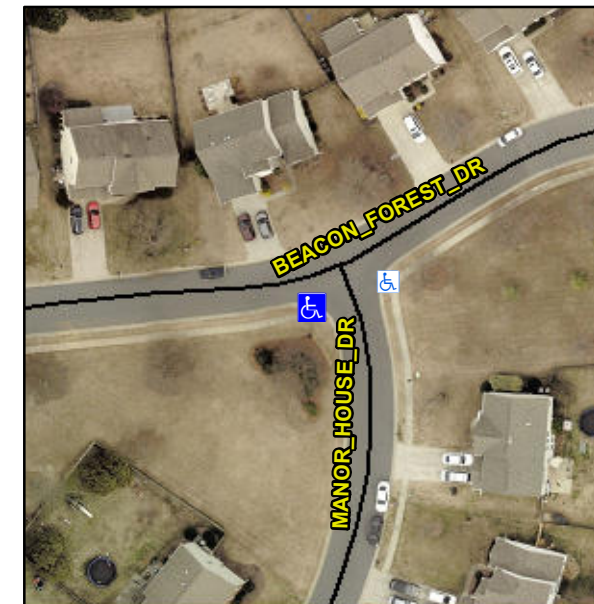
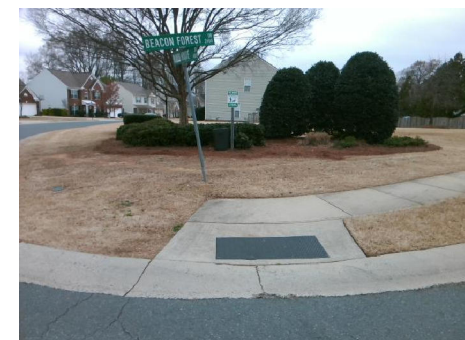
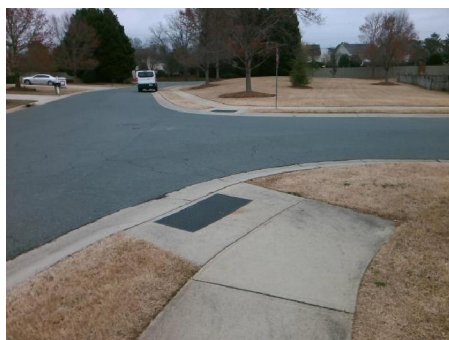
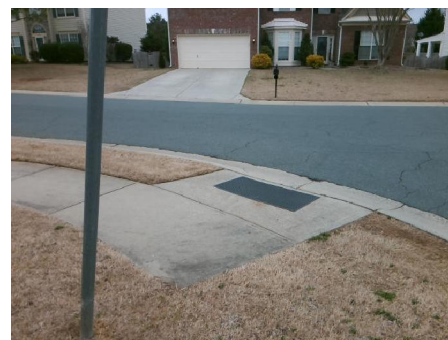
**Not Found, R304.5.1, R304.5.3**

Compliance	Description	Data	Compliance	Description	Data
N/A	Ramp Length (in)	48.0	Yes	BlendTrans Slope (%)	2.1
No	Ramp Width (in)	42.0	No	BlendTrans XSlope (%)	4.0
N/A	Flare Type LT	N/A	N/A	Flare Type RT	N/A
N/A	Flare Slope LT (%)	N/A	N/A	Flare Slope RT (%)	N/A
N/A	Flare Traversable LT?	N/A	N/A	Flare Traversable RT?	N/A
N/A	Landing Length (in)	N/A	N/A	DWS Provided?	N/A
N/A	Landing Width (in)	N/A	N/A	DWS Contrast?	N/A
N/A	Landing Slope (%)	N/A	N/A	DWS Length (in)	N/A
N/A	Landing X Slope (%)	N/A	N/A	DWS Full Width?	N/A
N/A	Landing Curb? (Y/N)	N/A	N/A	DWS Offset (in)	N/A
N/A	Shared Landing?	N/A			
N/A	Gutter Ponding?	N/A	N/A	Gutter Slope (%)	N/A
N/A	Gutter Lip Ht (in)	N/A	N/A	Gutter X Slope (%)	N/A
N/A	Painted X Walk1?	No	N/A	Painted X Walk2?	N/A
	X Walk 1 Direction	To NE		X Walk 2 Direction	N/A
	X Walk 1 Width (in)	N/A		X Walk 2 Width (in)	N/A
	X Walk 1 Slope (%)	1.7		X Walk 2 Slope (%)	N/A
	X Walk 1 X Slope (%)	3.8		X Walk 2 X Slope (%)	N/A

N/A	Ramp inside XWalk1?	N/A	N/A	Ramp inside XWalk2?	N/A
	Road Slope (%)	3.8		Clear Space?	N/A
	Road X Slope (%)	1.7	N/A	Clear Space to XWalk (in)	N/A
N/A	Any Obstructions?	N/A	N/A	Storm Grate/Utility Hazard?	N/A
	Obstruction Type			Storm Grate/Utility Type	
		N/A			N/A
			Yes	Surface Condition? (G/P)	Good
			No	Curb Slope (%)	13.4

**Remove & Replace Curb Ramp With Two New Directional Ramps or Equivalent.**
