Access Compliance Report

Public Rights-of-Way

(Curb Ramps)

Intersection ID: 25899	Main Street: ALDERMAN_LN	Cross Street: CARY_RIDGE_DR	Location: NE
ADA ID: E31619BD542F	Ramp Type: Perp	Initial Pass/Fail: Fail	Overall Compliance: No
Severity Score: 22.5			
Codes/Mitigation Info/Possible Solution		Field Measurements/Component Compliance

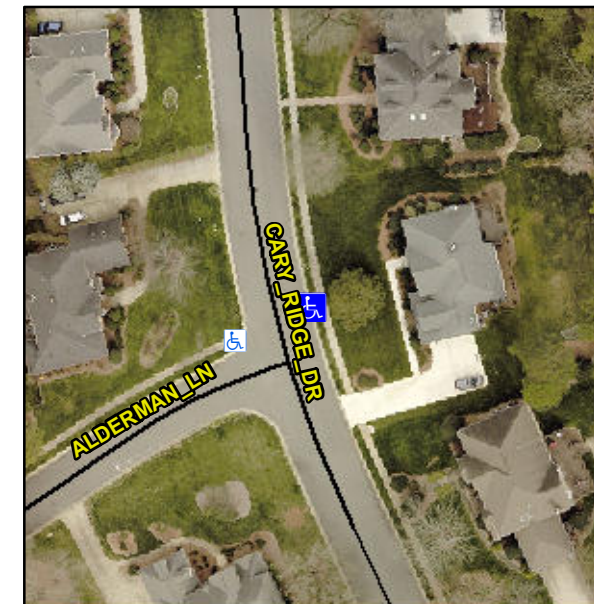
Not Found, R304.5.1, R304.2.2

Compliance	Description	Data	Compliance	Description	Data
N/A	Ramp Length (in)	47.0	No	Ramp Slope (%)	8.4
No	Ramp Width (in)	46.0	Yes	Ramp XSlope (%)	2.5
N/A	Flare Type LT	N/A	N/A	Flare Type RT	N/A
N/A	Flare Slope LT (%)	N/A	N/A	Flare Slope RT (%)	N/A
N/A	Flare Traversable LT?	N/A	N/A	Flare Traversable RT?	N/A
N/A	Landing Length (in)	N/A	N/A	DWS Provided?	N/A
N/A	Landing Width (in)	N/A	N/A	DWS Contrast?	N/A
N/A	Landing Slope (%)	N/A	N/A	DWS Length (in)	N/A
N/A	Landing X Slope (%)	N/A	N/A	DWS Full Width?	N/A
N/A	Landing Curb? (Y/N)	N/A	N/A	DWS Offset (in)	N/A
N/A	Shared Landing?	N/A			
N/A	Gutter Ponding?	N/A	N/A	Gutter Slope (%)	N/A
N/A	Gutter Lip Ht (in)	N/A	N/A	Gutter X Slope (%)	N/A
N/A	Painted X Walk1?	No	N/A	Painted X Walk2?	N/A
	X Walk 1 Direction	To SW		X Walk 2 Direction	N/A
N/A	X Walk 1 Width (in)	N/A	N/A	X Walk 2 Width (in)	N/A
	X Walk 1 Slope (%)	5.5		X Walk 2 Slope (%)	N/A
	X Walk 1 X Slope (%)	3.3		X Walk 2 X Slope (%)	N/A

Remove & Replace Entire Ramp.

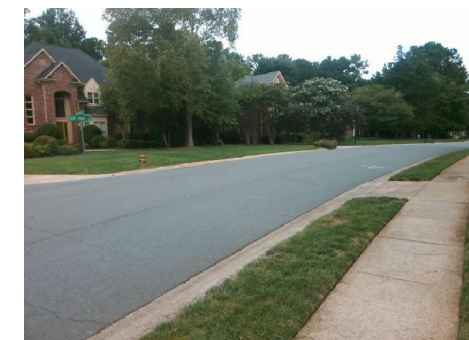
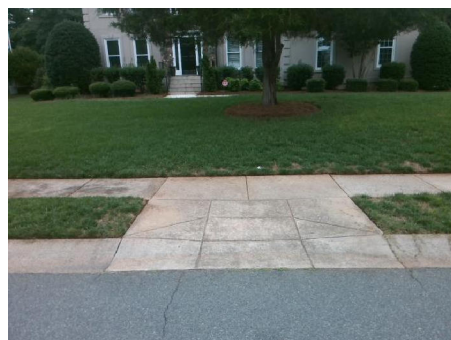
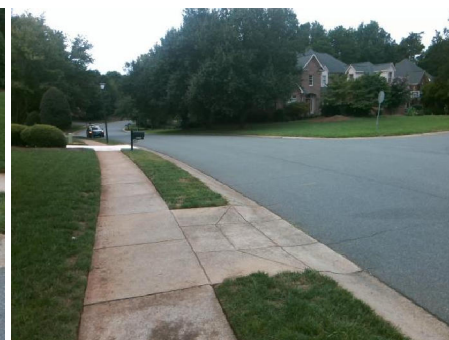
N/A	Ramp inside XWalk1?	N/A	N/A	Ramp inside XWalk2?	N/A
	Road Slope (%)	N/A	N/A	Clear Space?	N/A
	Road X Slope (%)	N/A	N/A	Clear Space to XWalk (in)	N/A
N/A	Any Obstructions?	N/A	N/A	Storm Grate/Utility Hazard?	N/A
	Obstruction Type			Storm Grate/Utility Type	
		N/A			N/A
			Yes	Surface Condition? (G/P)	Good
