Access Compliance Report

Public Rights-of-Way

(Curb Ramps)

Intersection ID: 14493	Main Street: CARONIA_ST	Cross Street: CLANTON_RD	Location: NW
ADA ID: E31941D4F0D3	Ramp Type: Directional1	Initial Pass/Fail: Fail	Overall Compliance: No
			Severity Score: 13.75

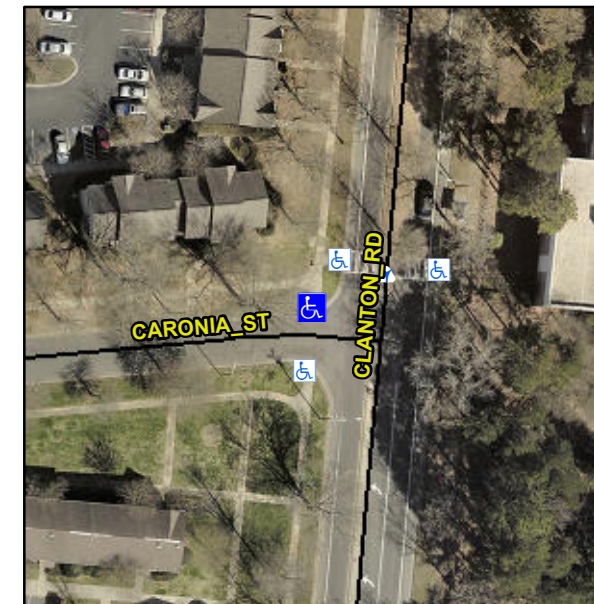
R304.2.2, R304.5.3

Compliance	Description	Data	Compliance	Description	Data
N/A	Ramp Length (in)	67.0	N/A	Grade Break?	N/A
Yes	Ramp Width (in)	59.0	N/A	Grade Break Slope (%)	0.0
No	Ramp Slope (%)	11.2	N/A	Grade Break XSlope (%)	0.0
No	Ramp XSlope (%)	2.3			
N/A	Flare Type LT	N/A	N/A	Flare Type RT	N/A
N/A	Flare Slope LT (%)	N/A	N/A	Flare Slope RT (%)	0.0
N/A	Flare Traversable LT?	N/A	N/A	Flare Traversable RT?	N/A
N/A	Landing Length (in)	0.0	N/A	DWS Provided?	N/A
N/A	Landing Width (in)	0.0	N/A	DWS Contrast?	N/A
N/A	Landing Slope (%)	0.0	N/A	DWS Length (in)	N/A
N/A	Landing X Slope (%)	0.0	N/A	DWS Full Width?	N/A
N/A	Landing Curb? (Y/N)	N/A	N/A	DWS Offset LT (in)	N/A
N/A	Shared Landing?	N/A	N/A	DWS Offset RT (in)	N/A
N/A	Gutter Ponding?	0.0	N/A	Gutter Slope (%)	N/A
N/A	Gutter Lip Ht (in)	0.0	N/A	Gutter X Slope (%)	N/A
N/A	Painted X Walk1?	No		Road Slope (%)	6.9
	X Walk 1 Direction	To SE		Road X Slope (%)	3.0
	X Walk 1 Width (in)	N/A		Clear Space?	N/A

X Walk 1 Slope (%)	6.9	N/A	Clear Space to XWalk (in)	N/A
	X Walk 1 X Slope (%)	3.0	N/A	Storm Grate/Utility Hazard?	N/A
N/A	Ramp inside XWalk1?	N/A		Storm Grate/Utility Type	
N/A	Any Obstructions?	N/A			N/A
	Obstruction Type		Yes	Surface Condition? (G/P)	Good
			N/A	Curb Slope (%)	4.8

Remove & Replace Entire Ramp.
