# Access Compliance Report

## Public Rights-of-Way

### (Curb Ramps)

| Intersection ID: 43657 | Main Street: TAYLOR RIDGE LN | Cross Street: SWANN BRANCH DR | Location: SE |

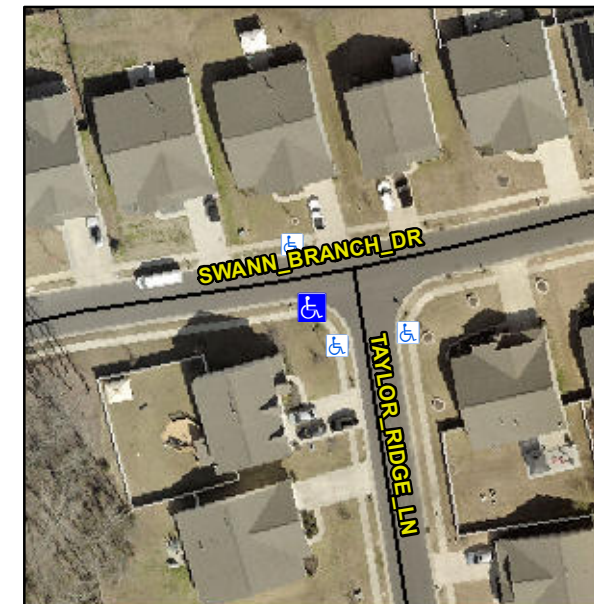
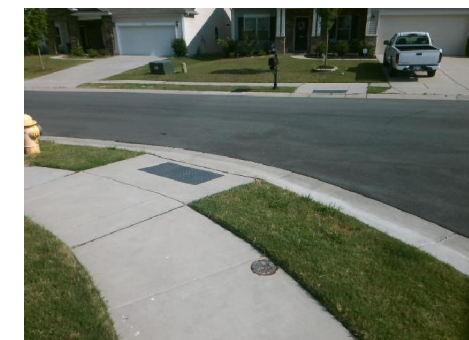
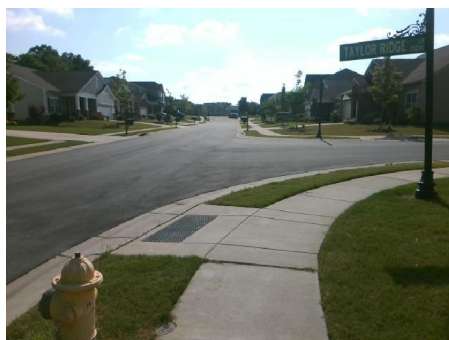
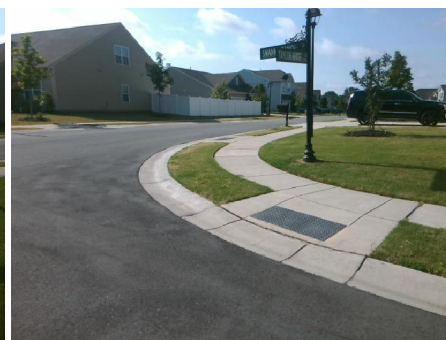
| ADA ID: E321FEAA68F8 | Ramp Type: Perp | Initial Pass/Fail: Fail | Overall Compliance: No |

| | | Severity Score: 35 | |

**R304.5.1, R304.2.2, R304.5.3**

| Compliance | Description | Data | Compliance | Description | Data |
|---|---|---|---|---|---|
| N/A | Ramp Length (in) | 48.0 | No | Ramp Slope (%) | 12.0 |
| No | Ramp Width (in) | 46.0 | No | Ramp XSlope (%) | 3.6 |

**Remove & Replace Entire Ramp.**

Total Cost: \$ 1850.00
