Access Compliance Report

Public Rights-of-Way

(Curb Ramps)

Intersection ID: 32245	Main Street: BALMORAL_PARK_DR	Cross Street: OXFORD_COMMONS_DR	Location: W
ADA ID: E3235FF43DC0	Ramp Type: Perp	Initial Pass/Fail: Fail	Overall Compliance: No
Severity Score: 37.5			
Codes/Mitigation Info/Possible Solution		Field Measurements/Component Compliance

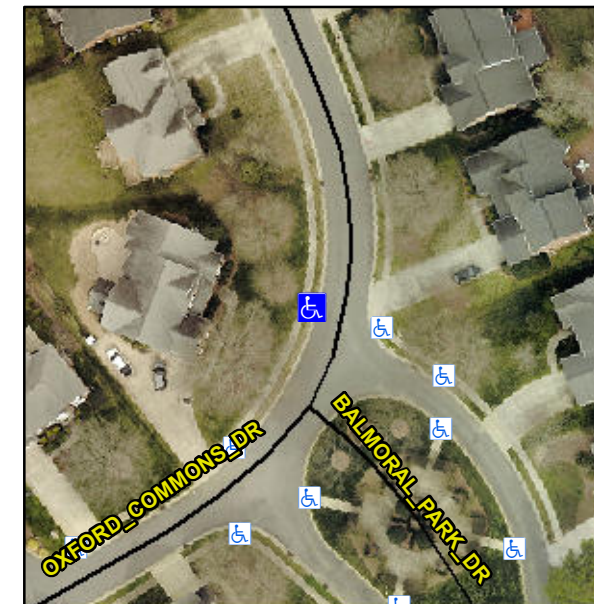
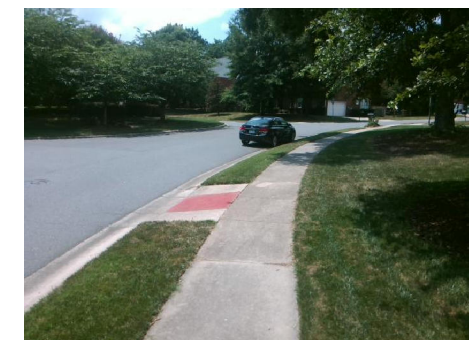
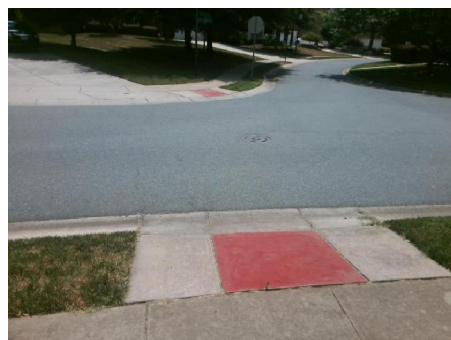
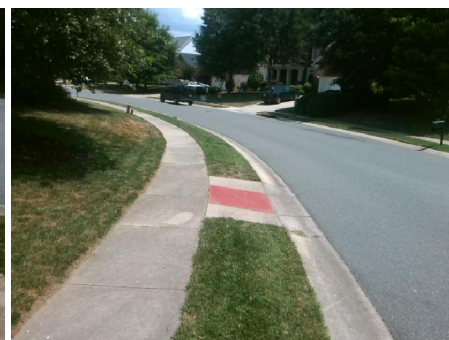
Not Found, R304.2.2, R304.5.3

Compliance	Description	Data	Compliance	Description	Data
N/A	Ramp Length (in)	47.5	No	Ramp Slope (%)	13.9
Yes	Ramp Width (in)	49.0	No	Ramp XSlope (%)	5.5
N/A	Flare Type LT	N/A	N/A	Flare Type RT	N/A
N/A	Flare Slope LT (%)	N/A	N/A	Flare Slope RT (%)	N/A
N/A	Flare Traversable LT?	N/A	N/A	Flare Traversable RT?	N/A
N/A	Landing Length (in)	N/A	N/A	DWS Provided?	N/A
N/A	Landing Width (in)	N/A	N/A	DWS Contrast?	N/A
N/A	Landing Slope (%)	N/A	N/A	DWS Length (in)	N/A
N/A	Landing X Slope (%)	N/A	N/A	DWS Full Width?	N/A
N/A	Landing Curb? (Y/N)	N/A	N/A	DWS Offset (in)	N/A
N/A	Shared Landing?	N/A			
N/A	Gutter Ponding?	N/A	N/A	Gutter Slope (%)	N/A
N/A	Gutter Lip Ht (in)	N/A	N/A	Gutter X Slope (%)	N/A
N/A	Painted X Walk1?	No	N/A	Painted X Walk2?	N/A
	X Walk 1 Direction	To SE		X Walk 2 Direction	N/A
N/A	X Walk 1 Width (in)	N/A	N/A	X Walk 2 Width (in)	N/A
	X Walk 1 Slope (%)	3.8		X Walk 2 Slope (%)	N/A
	X Walk 1 X Slope (%)	3.7		X Walk 2 X Slope (%)	N/A

N/A	Ramp inside XWalk1?	N/A	N/A	Ramp inside XWalk2?	N/A
	Road Slope (%)	N/A	N/A	Clear Space?	N/A
	Road X Slope (%)	N/A	N/A	Clear Space to XWalk (in)	N/A
N/A	Any Obstructions?	N/A	N/A	Storm Grate/Utility Hazard?	N/A
	Obstruction Type			Storm Grate/Utility Type	
		N/A			N/A
			Yes	Surface Condition? (G/P)	Good

Possible Solutions:

Remove & Replace Entire Ramp.
