Access Compliance Report

Public Rights-of-Way

(Curb Ramps)

Intersection ID: 10025341	Main Street: E_7TH_ST	Cross Street: N/A	Location: E
ADA ID: E323CAE73F34	Ramp Type: Directional1	Initial Pass/Fail: Fail	Overall Compliance: No
		Severity Score: 12.5	
Codes/Mitigation Info/Possible Solution		Field Measurements/Component Compliance

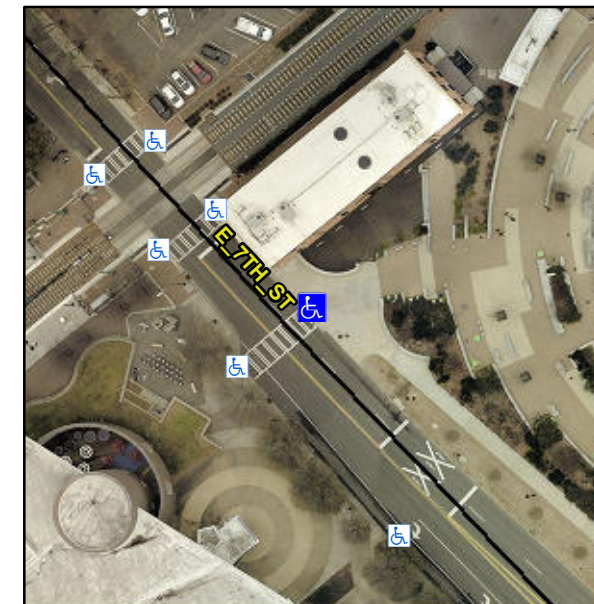
Compliance	Description	Data	Compliance	Description	Data
N/A	Ramp Length (in)	72.0	N/A	Grade Break?	N/A
Yes	Ramp Width (in)	48.0	N/A	Grade Break Slope (%)	0.0
No	Ramp Slope (%)	8.8	N/A	Grade Break XSlope (%)	0.0
Yes	Ramp XSlope (%)	0.6			
N/A	Flare Type LT	N/A	N/A	Flare Type RT	N/A
N/A	Flare Slope LT (%)	N/A	N/A	Flare Slope RT (%)	0.0
N/A	Flare Traversable LT?	N/A	N/A	Flare Traversable RT?	N/A
N/A	Landing Length (in)	0.0	N/A	DWS Provided?	N/A
N/A	Landing Width (in)	0.0	N/A	DWS Contrast?	N/A
N/A	Landing Slope (%)	0.0	N/A	DWS Length (in)	N/A
N/A	Landing X Slope (%)	0.0	N/A	DWS Full Width?	N/A
N/A	Landing Curb? (Y/N)	N/A	N/A	DWS Offset LT (in)	N/A
N/A	Shared Landing?	N/A	N/A	DWS Offset RT (in)	N/A
N/A	Gutter Ponding?	0.0	N/A	Gutter Slope (%)	N/A
N/A	Gutter Lip Ht (in)	0.0	N/A	Gutter X Slope (%)	N/A
N/A	Painted X Walk1?	Yes		Road Slope (%)	5.7
	X Walk 1 Direction	To SW		Road X Slope (%)	1.9
	X Walk 1 Width (in)	143.0		Clear Space?	N/A

X Walk 1 Slope (%)	5.7	N/A	Clear Space to XWalk (in)	N/A
	X Walk 1 X Slope (%)	1.9	N/A	Storm Grate/Utility Hazard?	N/A
N/A	Ramp inside XWalk1?	Yes		Storm Grate/Utility Type	
N/A	Any Obstructions?	N/A			N/A
	Obstruction Type		Yes	Surface Condition? (G/P)	Good
			N/A	Curb Slope (%)	5.4

Possible Solutions:

Remove & Replace Entire Ramp.
