Access Compliance Report

Public Rights-of-Way

(Curb Ramps)

| Intersection ID: 14974 | Main Street: CRESCENT_AV | Cross Street: WILLOUGHBY_ST | Location: SW |

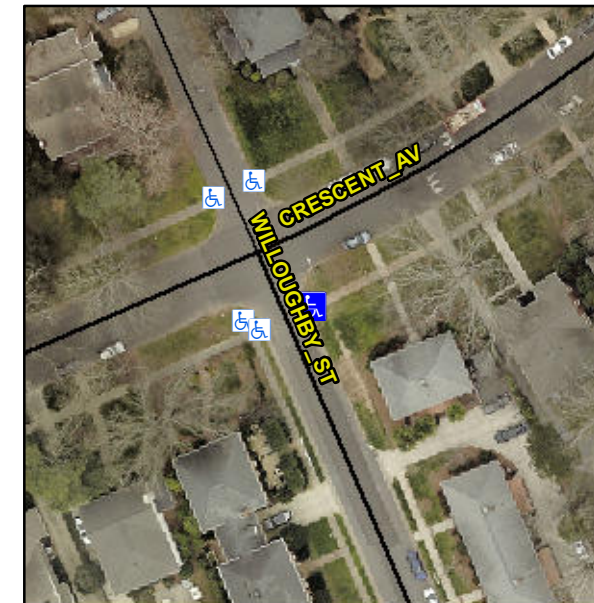
**Remove & Replace Entire Ramp.
Gutter Ponding Observed.**

| Compliance | Description | Data | Compliance | Description | Data |
|---|---|---|---|---|---|
| No | Landing Slope (%) | 3.6 | Yes | DWS Length (in) | 24.0 |
| Yes | Landing X Slope (%) | 1.5 | No | DWS Full Width? | No |
| No | Gutter Ponding? | Yes | Yes | Gutter Slope (%) | 3.6 |

Possible Solutions:
