Access Compliance Report

Public Rights-of-Way

(Curb Ramps)

Intersection ID: 28773	Main Street: ROYAL_HIGHLANDS_CT	Cross Street: THATCHER_HALL_CT	Location: SW
ADA ID: E32F240E3496	Ramp Type: BlendTrans1	Initial Pass/Fail: Pass	Overall Compliance: No
Severity Score: 17.75			
Codes/Mitigation Info/Possible Solution		Field Measurements/Component Compliance

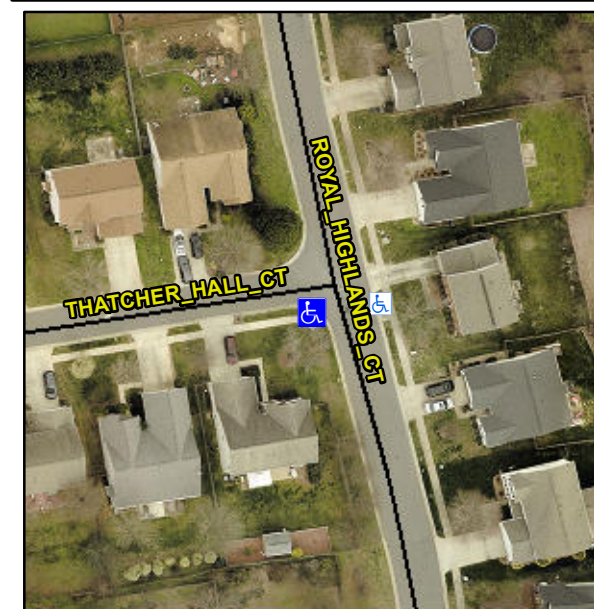
Not Found, R304.5.3, R305, R302.7.2

Compliance	Description	Data	Compliance	Description	Data
N/A	Ramp Length (in)	42.0	Yes	BlendTrans Slope (%)	3.4
Yes	Ramp Width (in)	51.0	No	BlendTrans XSlope (%)	4.4
N/A	Flare Type LT	Sloped	N/A	Flare Type RT	Sloped
N/A	Flare Slope LT (%)	9.2	N/A	Flare Slope RT (%)	1.5
N/A	Flare Traversable LT?	No	N/A	Flare Traversable RT?	No
Yes	Landing Length (in)	48.0	No	DWS Provided?	No
Yes	Landing Width (in)	51.0	N/A	DWS Contrast?	No
Yes	Landing Slope (%)	1.7	N/A	DWS Length (in)	N/A
No	Landing X Slope (%)	3.1	N/A	DWS Full Width?	No
N/A	Landing Curb? (Y/N)	No	N/A	DWS Offset (in)	N/A
N/A	Shared Landing?	No			
Yes	Gutter Ponding?	No	Yes	Gutter Slope (%)	2.5
No	Gutter Lip Ht (in)	0.3	No	Gutter X Slope (%)	4.2
N/A	Painted X Walk1?	No	N/A	Painted X Walk2?	N/A
	X Walk 1 Direction	To E		X Walk 2 Direction	N/A
	X Walk 1 Width (in)	N/A		X Walk 2 Width (in)	N/A
	X Walk 1 Slope (%)	2.9		X Walk 2 Slope (%)	N/A
	X Walk 1 X Slope (%)	0.9		X Walk 2 X Slope (%)	N/A

N/A	Ramp inside XWalk1?	N/A	N/A	Ramp inside XWalk2?	N/A
	Road Slope (%)	0.9		Clear Space?	Yes
	Road X Slope (%)	2.9	N/A	Clear Space to XWalk (in)	N/A
Yes	Any Obstructions?	No	Yes	Storm Grate/Utility Hazard?	No
	Obstruction Type			Storm Grate/Utility Type	
		N/A			N/A
			Yes	Surface Condition? (G/P)	Good
			No	Curb Slope (%)	5.1

Remove & Replace Curb Ramp With Two New Directional Ramps or Equivalent. Remove & Replace Gutter.
