Access Compliance Report

Public Rights-of-Way

(Curb Ramps)

Intersection ID: 6035	Main Street: BAXTER_CALDWELL_DR	Cross Street: JOSIE_ST	Location:	S
ADA ID: E336DB11FD50	Ramp Type: Perp	Initial Pass/Fail: Fail	Overall Compliance: No	Severity Score: 8.75
Codes/Mitigation Info/Possible Solution		Field Measurements/Component Compliance

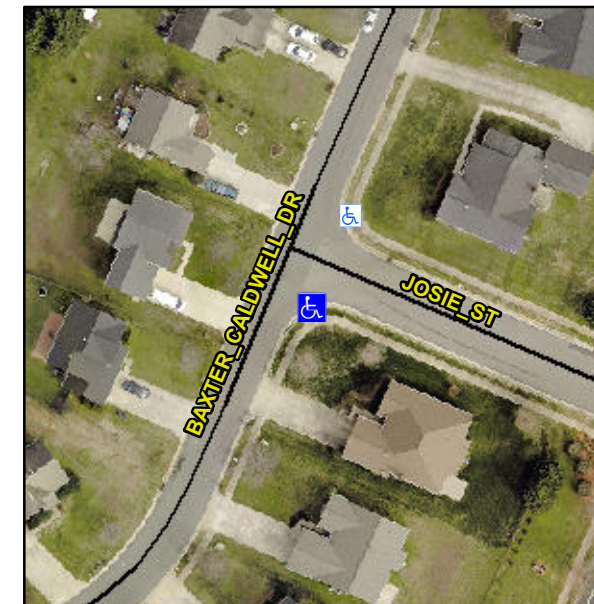
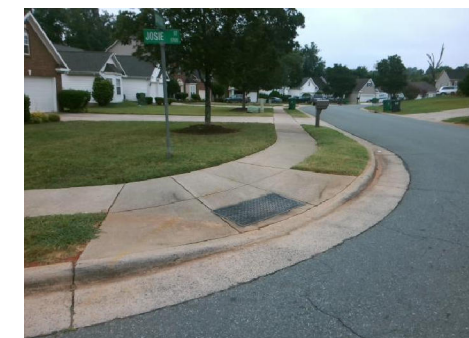
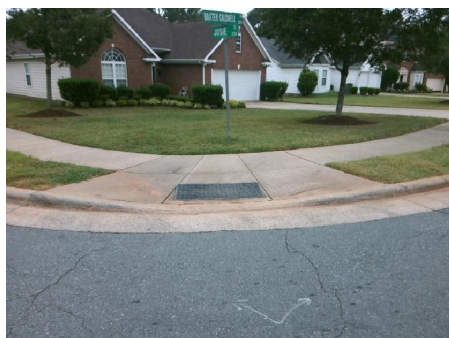
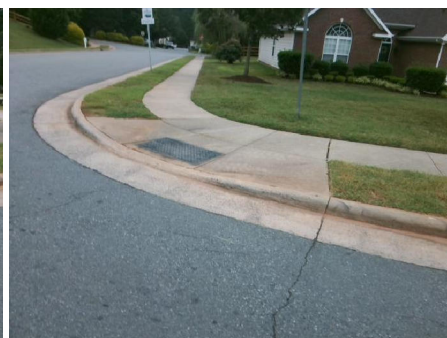
Not Found, R304.5.1

Compliance	Description	Data	Compliance	Description	Data
N/A	Ramp Length (in)	52.0	Yes	Ramp Slope (%)	5.2
No	Ramp Width (in)	39.5	Yes	Ramp XSlope (%)	1.4
N/A	Flare Type LT	N/A	N/A	Flare Type RT	N/A
N/A	Flare Slope LT (%)	N/A	N/A	Flare Slope RT (%)	N/A
N/A	Flare Traversable LT?	N/A	N/A	Flare Traversable RT?	N/A
N/A	Landing Length (in)	N/A	N/A	DWS Provided?	N/A
N/A	Landing Width (in)	N/A	N/A	DWS Contrast?	N/A
N/A	Landing Slope (%)	N/A	N/A	DWS Length (in)	N/A
N/A	Landing X Slope (%)	N/A	N/A	DWS Full Width?	N/A
N/A	Landing Curb? (Y/N)	N/A	N/A	DWS Offset (in)	N/A
N/A	Shared Landing?	N/A			
N/A	Gutter Ponding?	N/A	N/A	Gutter Slope (%)	N/A
N/A	Gutter Lip Ht (in)	N/A	N/A	Gutter X Slope (%)	N/A
N/A	Painted X Walk1?	No	N/A	Painted X Walk2?	N/A
	X Walk 1 Direction	To E		X Walk 2 Direction	N/A
N/A	X Walk 1 Width (in)	N/A	N/A	X Walk 2 Width (in)	N/A
	X Walk 1 Slope (%)	2.3		X Walk 2 Slope (%)	N/A
	X Walk 1 X Slope (%)	3.2		X Walk 2 X Slope (%)	N/A

N/A	Ramp inside XWalk1?	N/A	N/A	Ramp inside XWalk2?	N/A
	Road Slope (%)	N/A	N/A	Clear Space?	N/A
	Road X Slope (%)	N/A	N/A	Clear Space to XWalk (in)	N/A
N/A	Any Obstructions?	N/A	N/A	Storm Grate/Utility Hazard?	N/A
	Obstruction Type			Storm Grate/Utility Type	
		N/A			N/A
			Yes	Surface Condition? (G/P)	Good

Remove & Replace Entire Ramp.
