Access Compliance Report

Public Rights-of-Way

(Curb Ramps)

Intersection ID: 13546	Main Street: N_SHARON_AMITY_RD	Cross Street: TARRYWOOD_LN	Location:	W
ADA ID: E33B66A59430	Ramp Type: Perp	Initial Pass/Fail: Fail	Overall Compliance: No	Severity Score: 30
Codes/Mitigation Info/Possible Solution		Field Measurements/Component Compliance

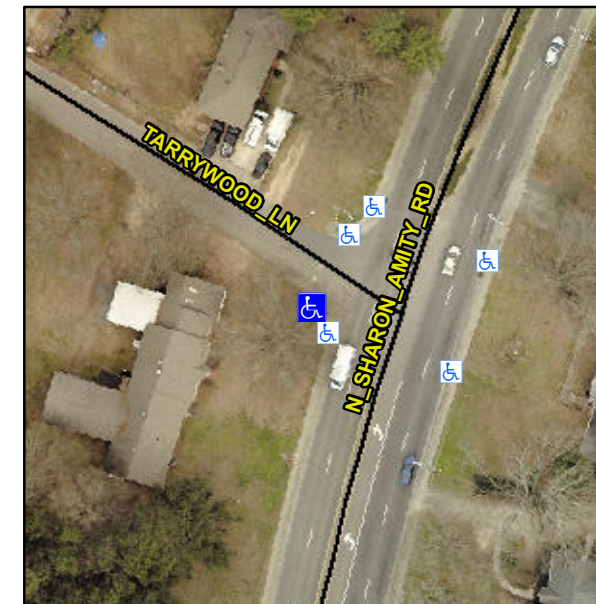
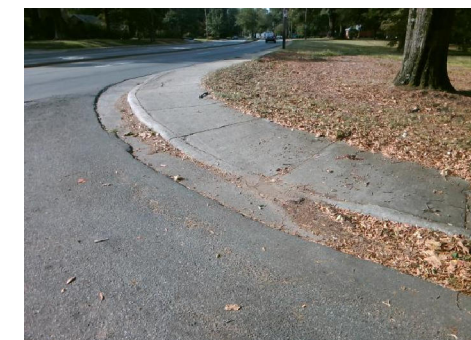
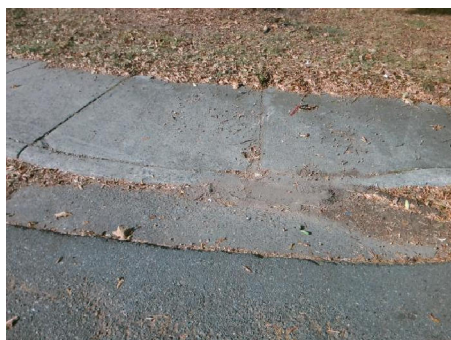
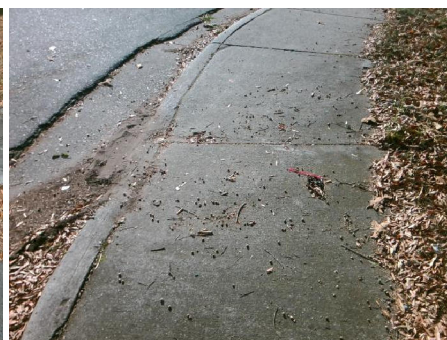
Not Found, R304.5.1, R304.2.2

Compliance	Description	Data	Compliance	Description	Data
N/A	Ramp Length (in)	59.5	No	Ramp Slope (%)	8.7
No	Ramp Width (in)	32.0	Yes	Ramp XSlope (%)	1.6
N/A	Flare Type LT	N/A	N/A	Flare Type RT	N/A
N/A	Flare Slope LT (%)	N/A	N/A	Flare Slope RT (%)	N/A
N/A	Flare Traversable LT?	N/A	N/A	Flare Traversable RT?	N/A
N/A	Landing Length (in)	N/A	N/A	DWS Provided?	N/A
N/A	Landing Width (in)	N/A	N/A	DWS Contrast?	N/A
N/A	Landing Slope (%)	N/A	N/A	DWS Length (in)	N/A
N/A	Landing X Slope (%)	N/A	N/A	DWS Full Width?	N/A
N/A	Landing Curb? (Y/N)	N/A	N/A	DWS Offset (in)	N/A
N/A	Shared Landing?	N/A			
N/A	Gutter Ponding?	Yes	N/A	Gutter Slope (%)	N/A
N/A	Gutter Lip Ht (in)	3.0	N/A	Gutter X Slope (%)	N/A
N/A	Painted X Walk1?	No	N/A	Painted X Walk2?	N/A
	X Walk 1 Direction	To N		X Walk 2 Direction	N/A
N/A	X Walk 1 Width (in)	N/A	N/A	X Walk 2 Width (in)	N/A
	X Walk 1 Slope (%)	3.6		X Walk 2 Slope (%)	N/A
	X Walk 1 X Slope (%)	4.6		X Walk 2 X Slope (%)	N/A

N/A	Ramp inside XWalk1?	N/A	N/A	Ramp inside XWalk2?	N/A
	Road Slope (%)	N/A	N/A	Clear Space?	N/A
	Road X Slope (%)	N/A	N/A	Clear Space to XWalk (in)	N/A
N/A	Any Obstructions?	N/A	N/A	Storm Grate/Utility Hazard?	N/A
	Obstruction Type			Storm Grate/Utility Type	
		N/A			N/A
		Yes		Surface Condition? (G/P)	Good

Possible Solutions:

Remove & Replace Entire Ramp.
