Access Compliance Report

Public Rights-of-Way

(Curb Ramps)

Intersection ID: 46917	Main Street: RAISIN_TREE_LN	Cross Street: MONARCH_BIRCH_LN	Location: SE
ADA ID: E348AAE85A46	Ramp Type: PerpDiag	Initial Pass/Fail: Fail	Overall Compliance: No
Severity Score: 22.5			
Codes/Mitigation Info/Possible Solution		Field Measurements/Component Compliance

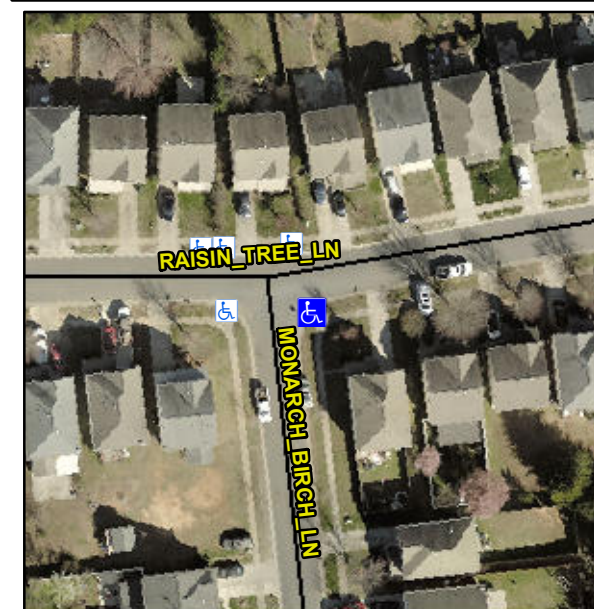
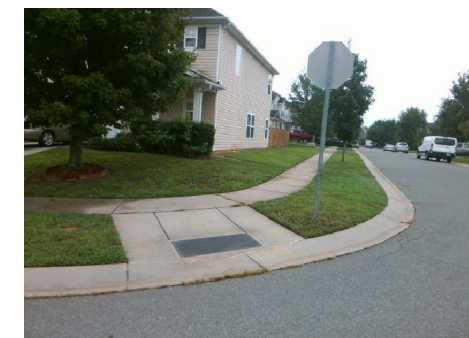
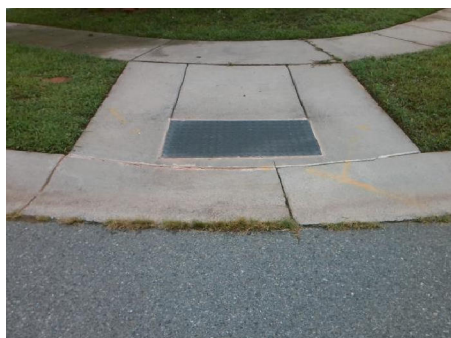
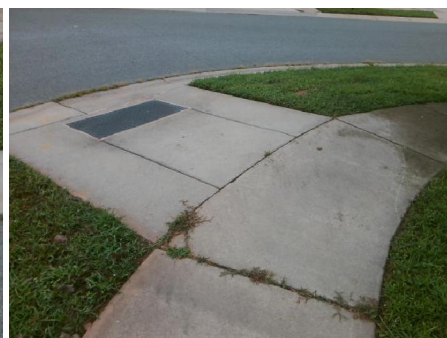
Not Found, R304.5.1, R304.2.2, R304.5.3

Compliance	Description	Data	Compliance	Description	Data
N/A	Ramp Length (in)	86.5	No	Ramp Slope (%)	10.0
No	Ramp Width (in)	47.0	No	Ramp XSlope (%)	4.7
N/A	Flare Type LT	N/A	N/A	Flare Type RT	N/A
N/A	Flare Slope LT (%)	N/A	N/A	Flare Slope RT (%)	N/A
N/A	Flare Traversable LT?	N/A	N/A	Flare Traversable RT?	N/A
N/A	Landing Length (in)	N/A	N/A	DWS Provided?	N/A
N/A	Landing Width (in)	N/A	N/A	DWS Contrast?	N/A
N/A	Landing Slope (%)	N/A	N/A	DWS Length (in)	N/A
N/A	Landing X Slope (%)	N/A	N/A	DWS Full Width?	N/A
N/A	Landing Curb? (Y/N)	N/A	N/A	DWS Offset (in)	N/A
N/A	Shared Landing?	N/A			
N/A	Gutter Ponding?	N/A	N/A	Gutter Slope (%)	N/A
N/A	Gutter Lip Ht (in)	N/A	N/A	Gutter X Slope (%)	N/A
N/A	Painted X Walk1?	No	N/A	Painted X Walk2?	No
	X Walk 1 Direction	To N		X Walk 2 Direction	To W
N/A	X Walk 1 Width (in)	N/A	N/A	X Walk 2 Width (in)	N/A
	X Walk 1 Slope (%)	2.0		X Walk 2 Slope (%)	3.7
	X Walk 1 X Slope (%)	6.0		X Walk 2 X Slope (%)	0.1

N/A	Ramp inside XWalk1?	N/A	N/A	Ramp inside XWalk2?	N/A
	Road Slope (%)	4.1	N/A	Clear Space?	N/A
	Road X Slope (%)	4.5	N/A	Clear Space to XWalk (in)	N/A
N/A	Any Obstructions?	N/A	N/A	Storm Grate/Utility Hazard?	N/A
	Obstruction Type			Storm Grate/Utility Type	
		N/A			N/A
			Yes	Surface Condition? (G/P)	Good

Remove & Replace Curb Ramp With Two New Directional Ramps or Equivalent.
