Access Compliance Report

Public Rights-of-Way

(Curb Ramps)

Intersection ID: 26209	Main Street: CARMEL_RD	Cross Street: JOHNSTON_RD	Location: E
ADA ID: E348D9128E39	Ramp Type: Perp	Initial Pass/Fail: Fail	Overall Compliance: No
Severity Score: 21.25			
Codes/Mitigation Info/Possible Solution		Field Measurements/Component Compliance

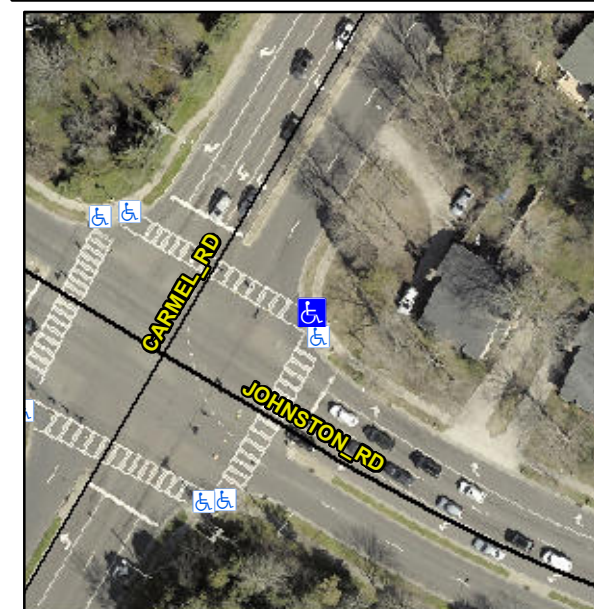
Not Found, R304.5.1, R304.2.2

Compliance	Description	Data	Compliance	Description	Data
N/A	Ramp Length (in)	59.0	No	Ramp Slope (%)	8.7
No	Ramp Width (in)	43.0	Yes	Ramp XSlope (%)	0.3
N/A	Flare Type LT	N/A	N/A	Flare Type RT	N/A
N/A	Flare Slope LT (%)	N/A	N/A	Flare Slope RT (%)	N/A
N/A	Flare Traversable LT?	N/A	N/A	Flare Traversable RT?	N/A
N/A	Landing Length (in)	N/A	N/A	DWS Provided?	N/A
N/A	Landing Width (in)	N/A	N/A	DWS Contrast?	N/A
N/A	Landing Slope (%)	N/A	N/A	DWS Length (in)	N/A
N/A	Landing X Slope (%)	N/A	N/A	DWS Full Width?	N/A
N/A	Landing Curb? (Y/N)	N/A	N/A	DWS Offset (in)	N/A
N/A	Shared Landing?	N/A			
N/A	Gutter Ponding?	N/A	N/A	Gutter Slope (%)	N/A
N/A	Gutter Lip Ht (in)	N/A	N/A	Gutter X Slope (%)	N/A
N/A	Painted X Walk1?	Yes	N/A	Painted X Walk2?	N/A
	X Walk 1 Direction	To NW		X Walk 2 Direction	N/A
N/A	X Walk 1 Width (in)	114.0	N/A	X Walk 2 Width (in)	N/A
	X Walk 1 Slope (%)	3.7		X Walk 2 Slope (%)	N/A
	X Walk 1 X Slope (%)	1.6		X Walk 2 X Slope (%)	N/A

N/A	Ramp inside XWalk1?	Yes	N/A	Ramp inside XWalk2?	N/A
	Road Slope (%)	N/A	N/A	Clear Space?	N/A
	Road X Slope (%)	N/A	N/A	Clear Space to XWalk (in)	N/A
N/A	Any Obstructions?	N/A	N/A	Storm Grate/Utility Hazard?	N/A
	Obstruction Type			Storm Grate/Utility Type	
		N/A			N/A
		Yes		Surface Condition? (G/P)	Good

Possible Solutions:

Remove & Replace Entire Ramp.
