Access Compliance Report

Public Rights-of-Way

(Curb Ramps)

Intersection ID: 14479	Main Street: BARNHILL_DR	Cross Street: PINECREST_AV	Location: NE
ADA ID: E349327A5A46	Ramp Type: Perp	Initial Pass/Fail: Fail	Overall Compliance: No
		Severity Score: 25

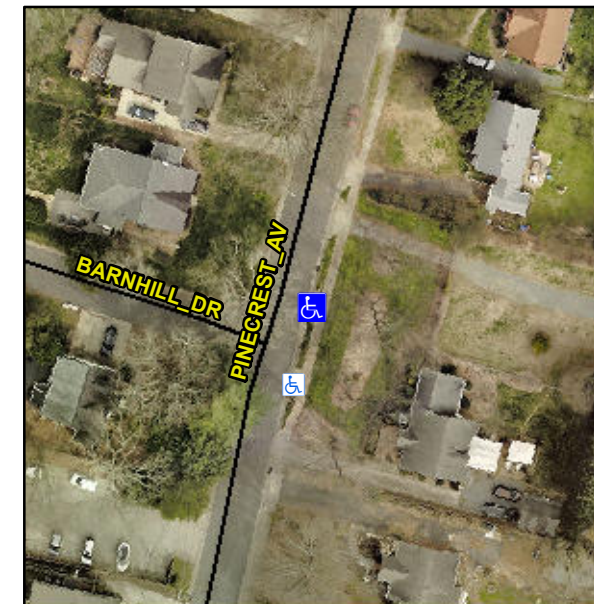
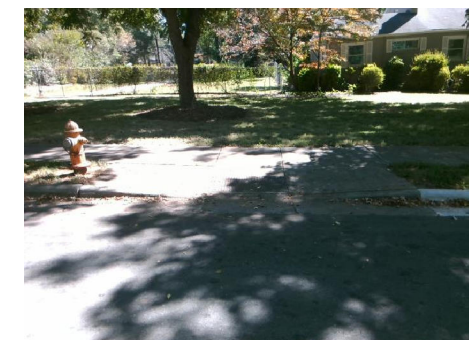
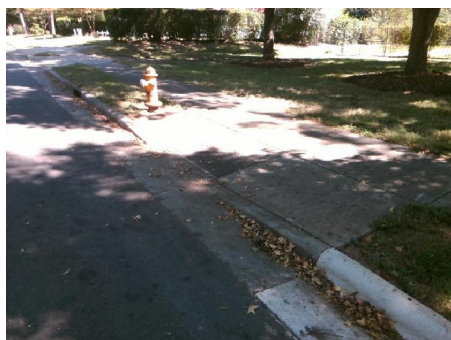
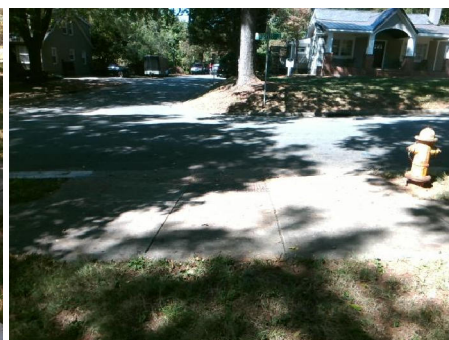
Not Found, R304.2.2, R304.5.3

Compliance	Description	Data	Compliance	Description	Data
N/A	Ramp Length (in)	48.0	No	Ramp Slope (%)	9.4
Yes	Ramp Width (in)	48.5	No	Ramp XSlope (%)	6.3
N/A	Flare Type LT	N/A	N/A	Flare Type RT	N/A
N/A	Flare Slope LT (%)	N/A	N/A	Flare Slope RT (%)	N/A
N/A	Flare Traversable LT?	N/A	N/A	Flare Traversable RT?	N/A
N/A	Landing Length (in)	N/A	N/A	DWS Provided?	N/A
N/A	Landing Width (in)	N/A	N/A	DWS Contrast?	N/A
N/A	Landing Slope (%)	N/A	N/A	DWS Length (in)	N/A
N/A	Landing X Slope (%)	N/A	N/A	DWS Full Width?	N/A
N/A	Landing Curb? (Y/N)	N/A	N/A	DWS Offset (in)	N/A
N/A	Shared Landing?	N/A			
N/A	Gutter Ponding?	N/A	N/A	Gutter Slope (%)	N/A
N/A	Gutter Lip Ht (in)	N/A	N/A	Gutter X Slope (%)	N/A
N/A	Painted X Walk1?	No	N/A	Painted X Walk2?	N/A
	X Walk 1 Direction	To W		X Walk 2 Direction	N/A
N/A	X Walk 1 Width (in)	N/A	N/A	X Walk 2 Width (in)	N/A
	X Walk 1 Slope (%)	6.8		X Walk 2 Slope (%)	N/A
	X Walk 1 X Slope (%)	4.2		X Walk 2 X Slope (%)	N/A

N/A	Ramp inside XWalk1?	N/A	N/A	Ramp inside XWalk2?	N/A
	Road Slope (%)	N/A	N/A	Clear Space?	N/A
	Road X Slope (%)	N/A	N/A	Clear Space to XWalk (in)	N/A
N/A	Any Obstructions?	N/A	N/A	Storm Grate/Utility Hazard?	N/A
	Obstruction Type			Storm Grate/Utility Type	
		N/A			N/A
			Yes	Surface Condition? (G/P)	Good

Remove & Replace Entire Ramp.
